Derbyshire Dales Group Major Projects

Current Project

1970 MG B GT 1.8L

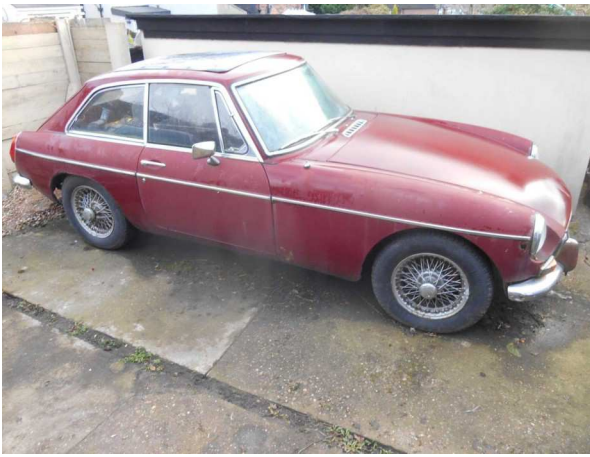
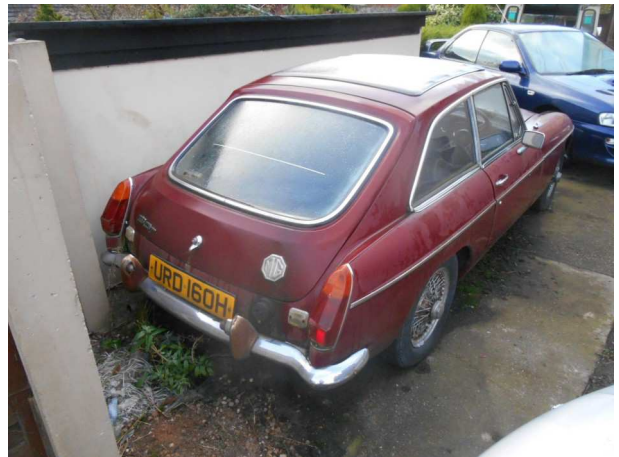
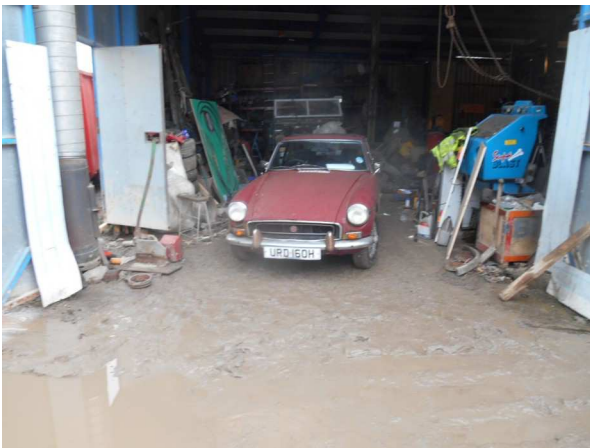
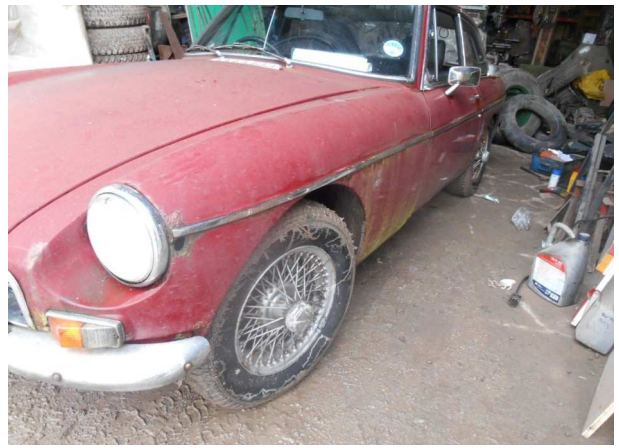
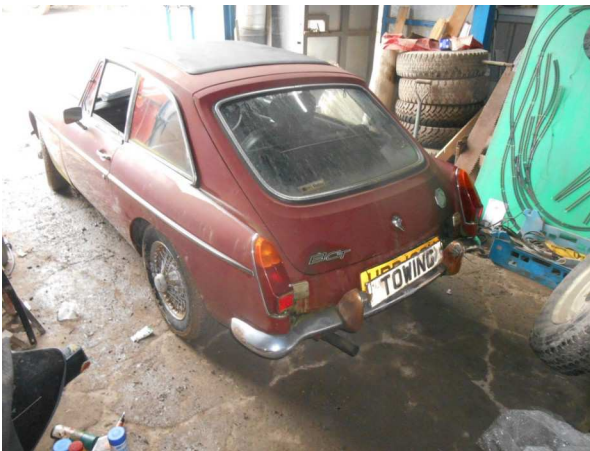
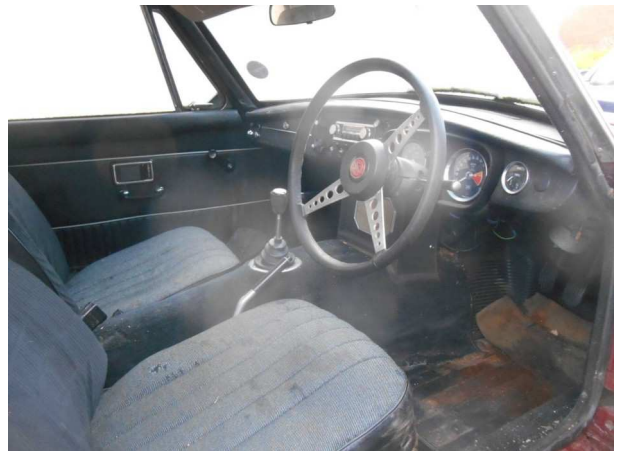
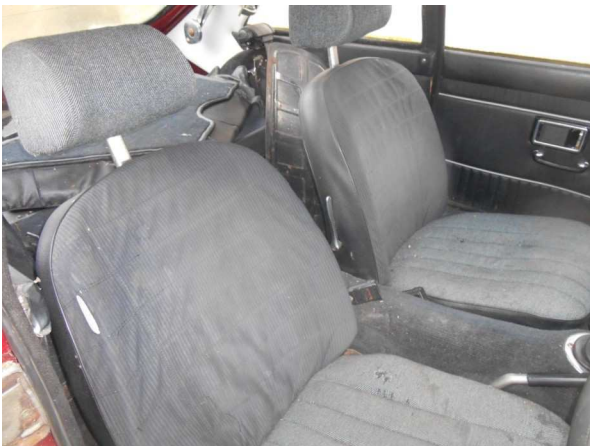
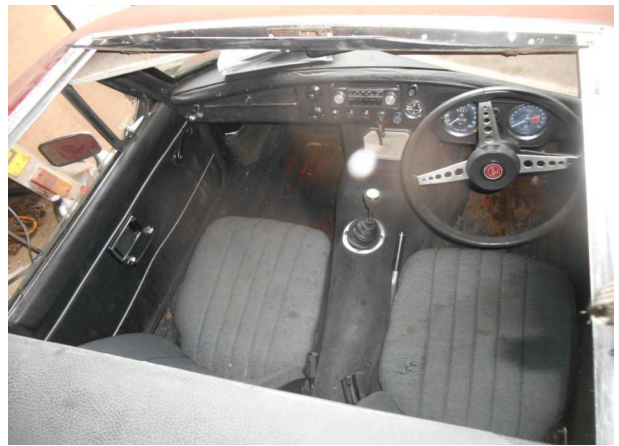
The condition of Ryan's MGB GT on arrival

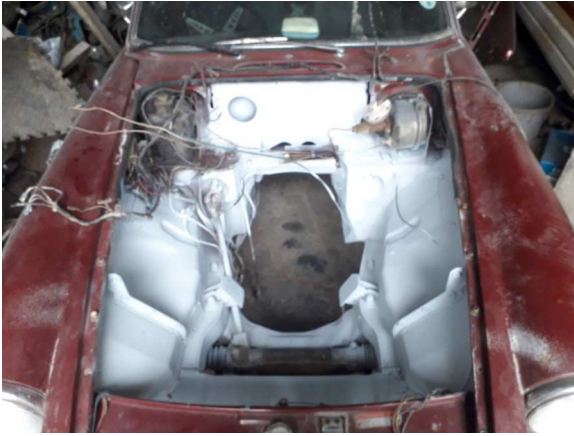
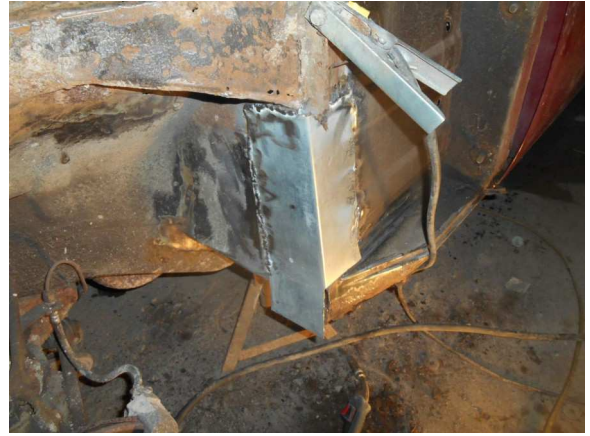
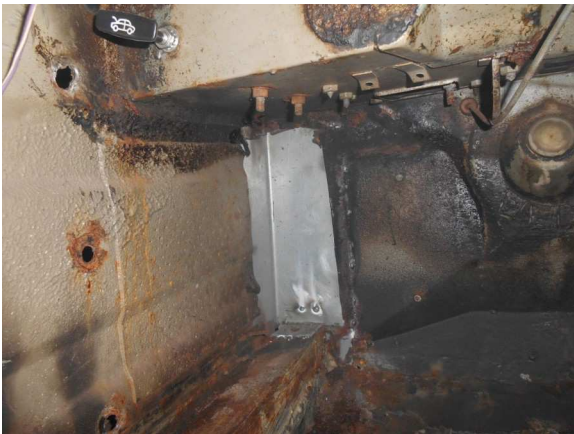
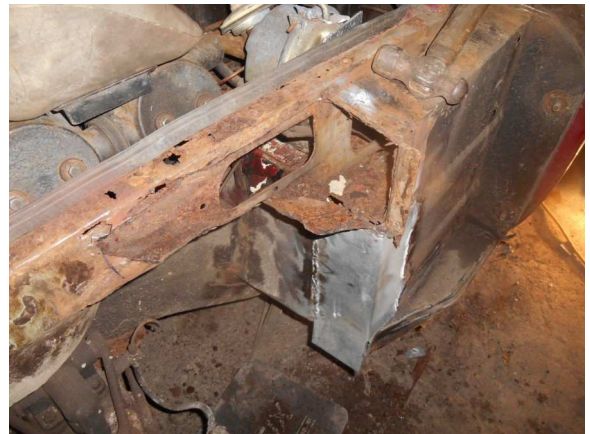
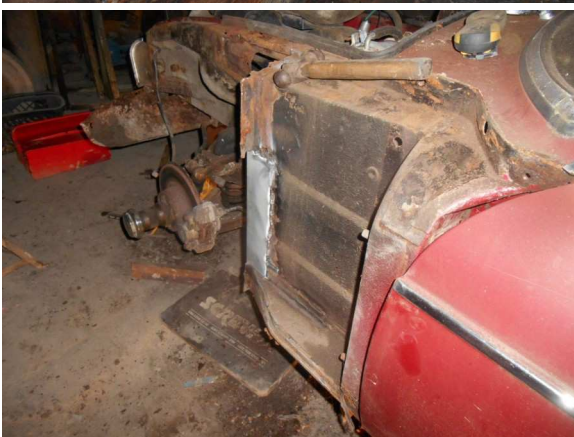
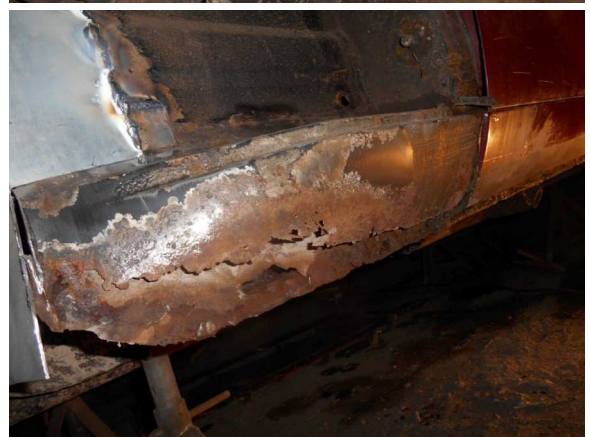
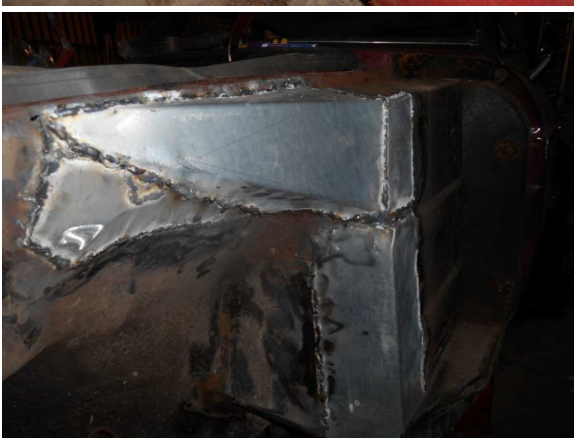
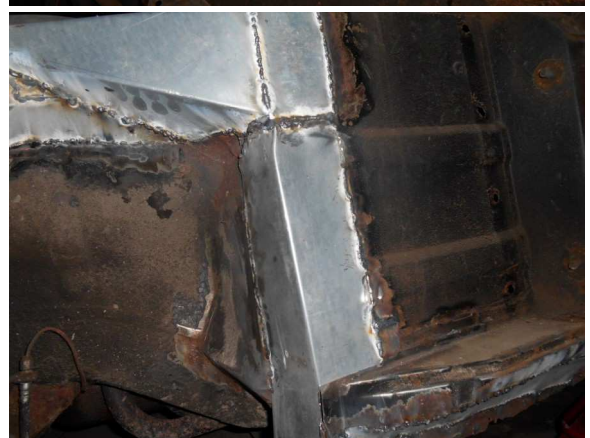
Restoration work in progress

The next task was the bodywork, which was completed over the next 5-6 months with help from my father and friends. The front inner wings were patched up from panels which I fabricated. A lot of this car was clearly in ok condition and had been replaced before, including floor pans, sills and castle rails. However on further investigation the driver's side sill was rather tired and was to benefit from replacement. Knowing that specialists charge up to £1000 for this type of work, with the aid of 'You Tube' I managed to determine the anatomy of the car's structure and how to put it back together, once again fabricating my own panels and buying the external panels new from Rimmers where necessary.

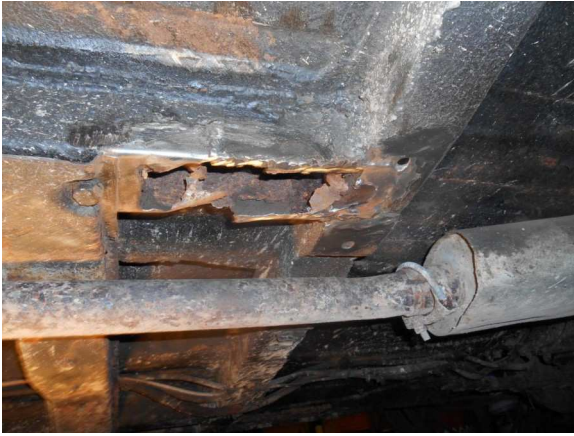
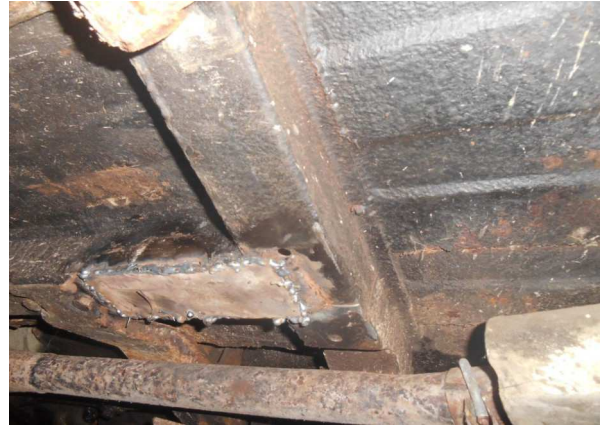
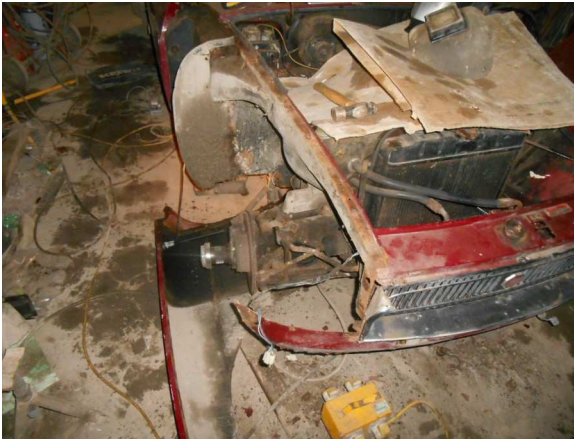
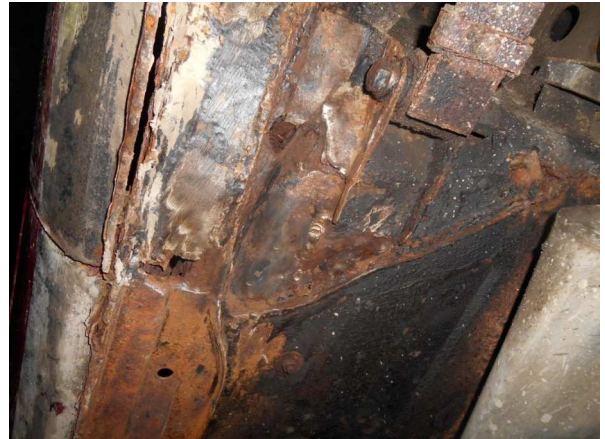
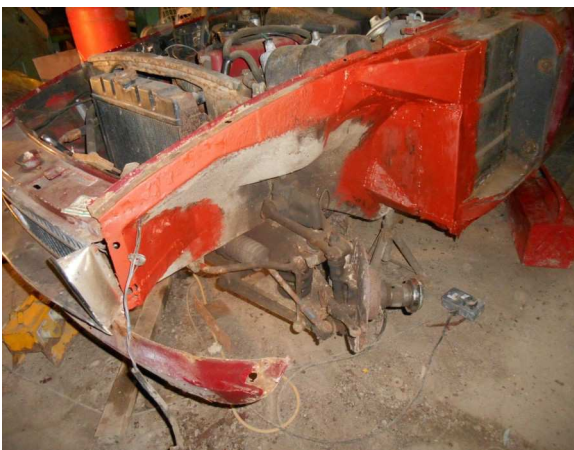
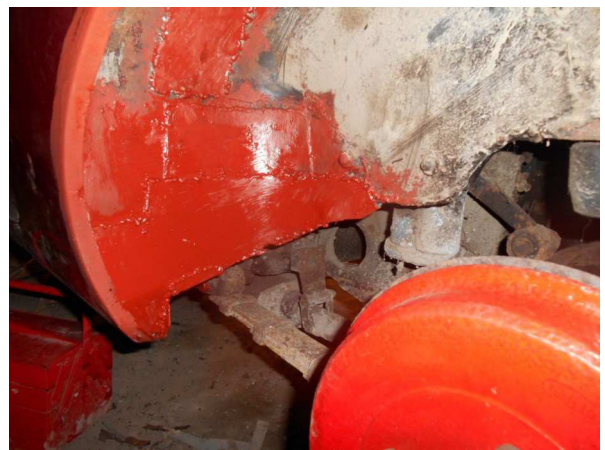
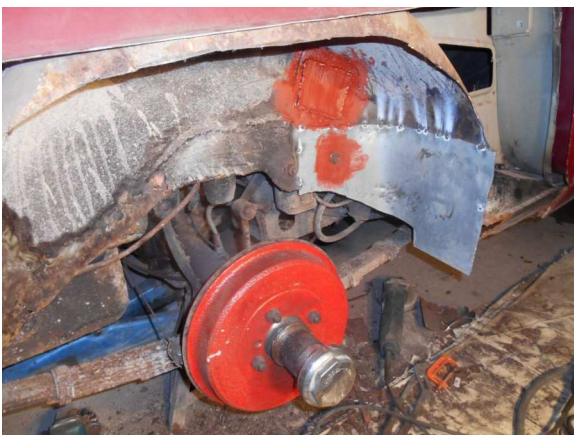
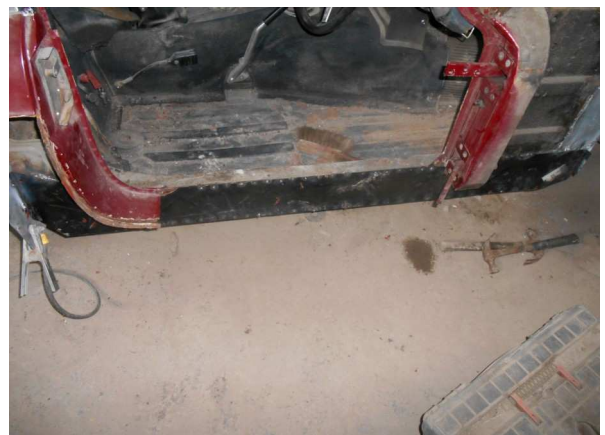
On With The Welding
