John Browett.

John's current project is a ground-floor-up restoration of an Austin Healey 3000 MkII

Car Model:	Austin Healey 3000 MkII BT7. Late sliding window model, probably last of tri-carb series
Year of Manufacture:	September 1961
Country of Original Reg:	Ohio, USA
Car Acquired:	March/April 2015
Project Commenced:	November 2015

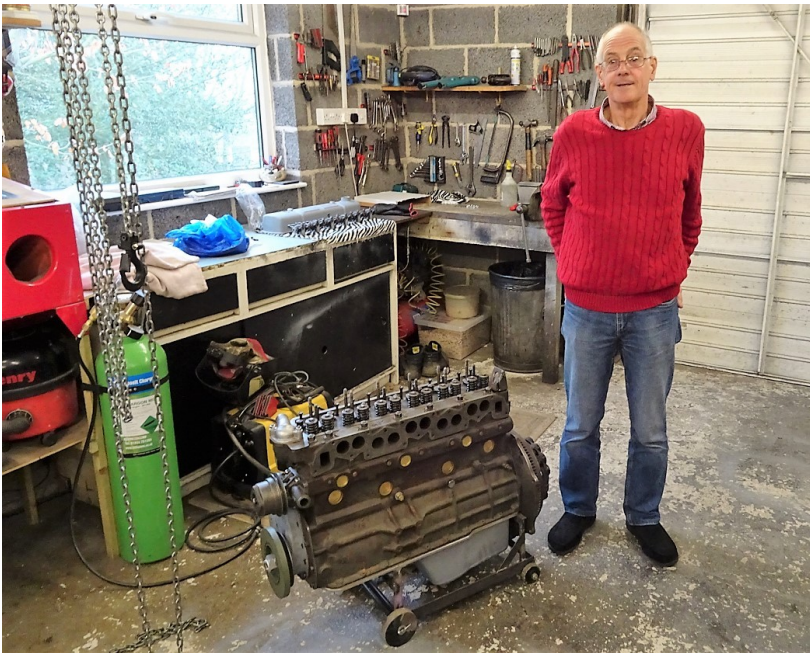
John with his A-H engine block

The engine block had been re-assembled as has the gearbox. There has been a problem with the gearbox output shaft being too short, apparently a universal problem on A-Hs, and there has been a problem with a uni-directional (Sprag) clutch in the overdrive. Overdrive Repair Services'ex-Laycock Engineers have been involved in resolving this.

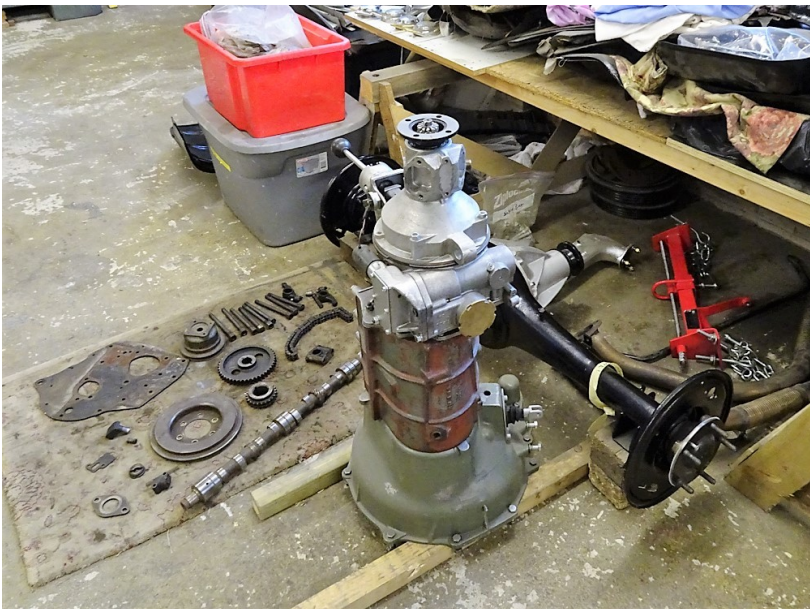
Gearbox and overdrive ready for installation

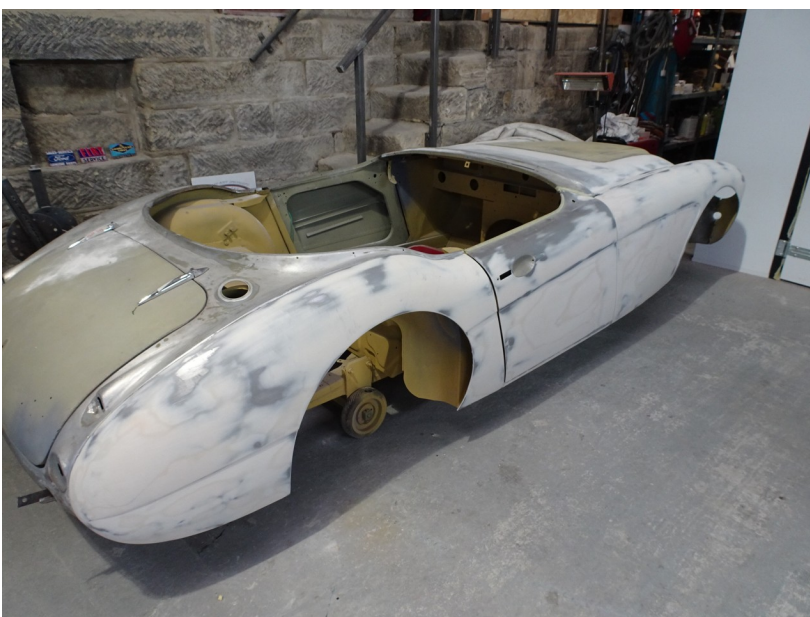
Tub in preparation for paint

The body shell has been separated from the mis-formed chassis and the panels re-welded to the straightened chassis and made ready for spraying. One new wing along with a dozen or so internal new panels was purchased. The majority of the other panels were repaired to some extent. John is happy to undertake any works such as these, but does not undertake filling and painting. The body-shell is now at Classic Gas' paint shop, in primer/filler, having been delivered there in late January 2018, leaving John to get on with the mechanicals.
