In The Garage

Feb 2023

Issue 17

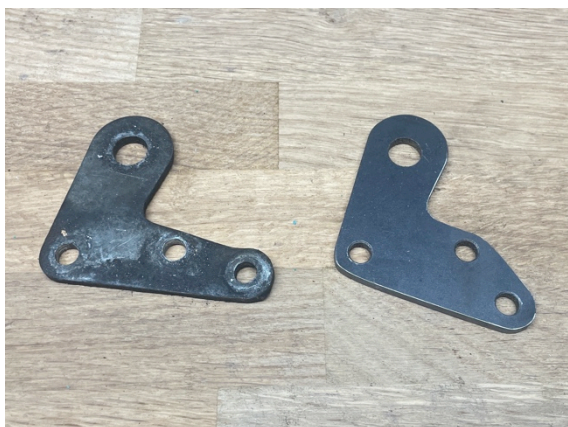
The original bracket on the left and the modified version on the right.

The ratchet is attached by a single bolt through its lower end onto a bracket bolted to the chassis. A new bracket was sketched up with the ratchet attachment as low as it would go before the bottom of the lever hit the chassis mounting. This was only about 5/8" lower than standard but a small change close to the lever pivot translates to a much greater change at the handle. A new modified bracket was cut from a piece of mild steel plate and bolted to the chassis. The handbrake assembly was then bolted back onto the chassis with the ratchet secured in the new position and the cables were adjusted to suit the revised assembly.

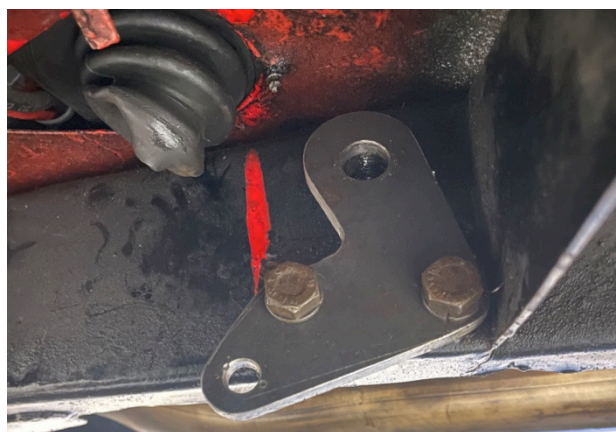
The new bracket in position on the chassis.

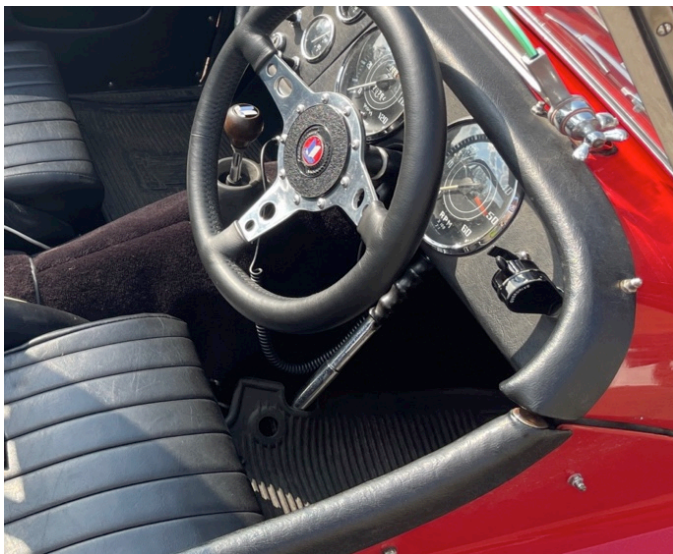
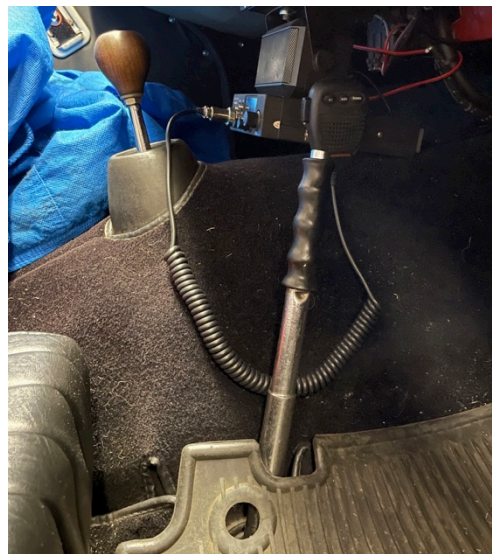
I neglected to take a dedicated "before" photo but this recent picture of the cockpit shows how much further forward the lever was compared with the "after" photo on the right.

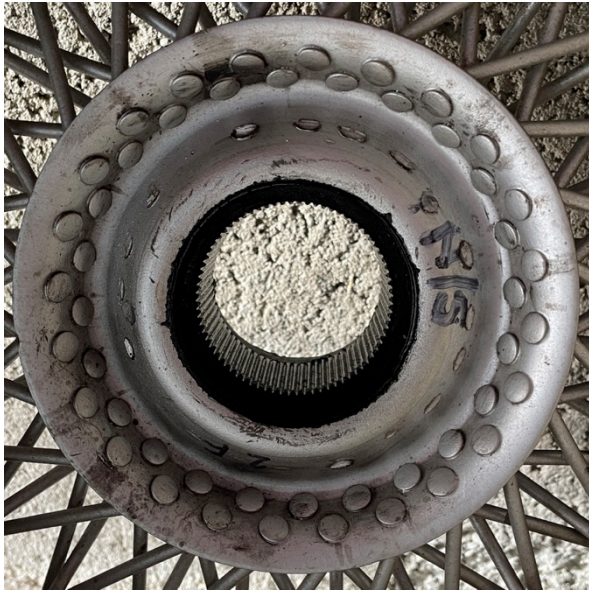
The marks left by the incorrect, longer steel wheel studs are plain to see on the back of the hub. The wheel must have been on and off a number of times to cause that amount of 'stud rash' so it's hard to understand how it wasn't spotted after multiple problems with loose wheels.

Wire wheel hub showing "stud rash"

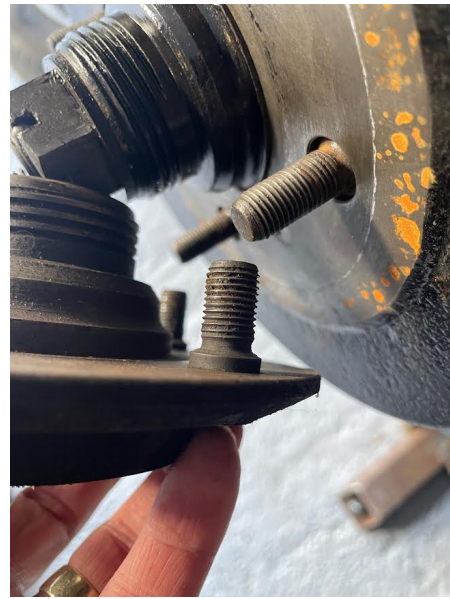
Long and short studs compared

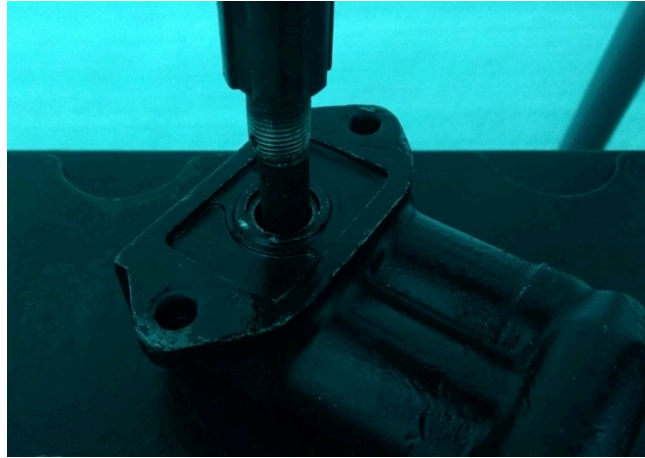
- 4) Press the arm out (it's a press fit in the internal rocker) and clean the base of the axle where it has been sitting inside the old seal. Mine was a bit corroded and needed some fine wet and dry to clean it up.

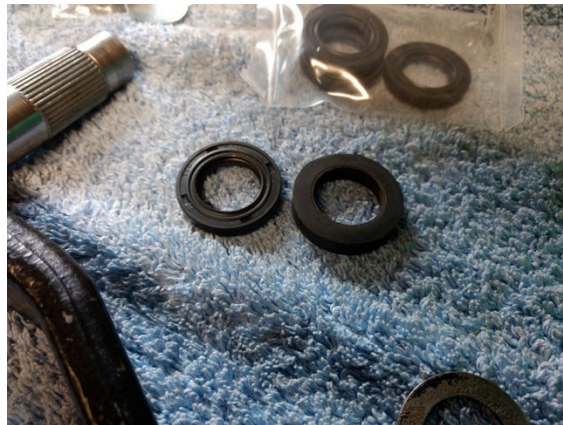
- 5) Remove the old rubber seal and retaining washer – the old seal is easily removed. Mine was really crusty and slightly perished on the inside.

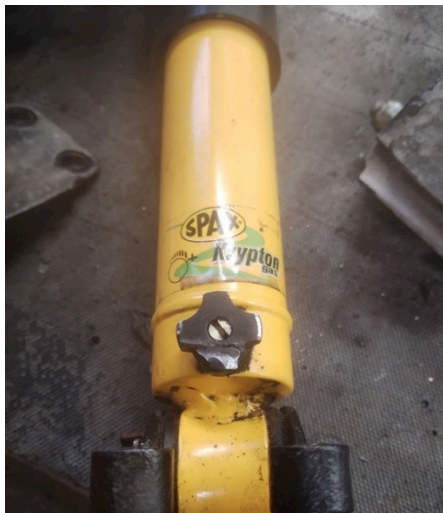
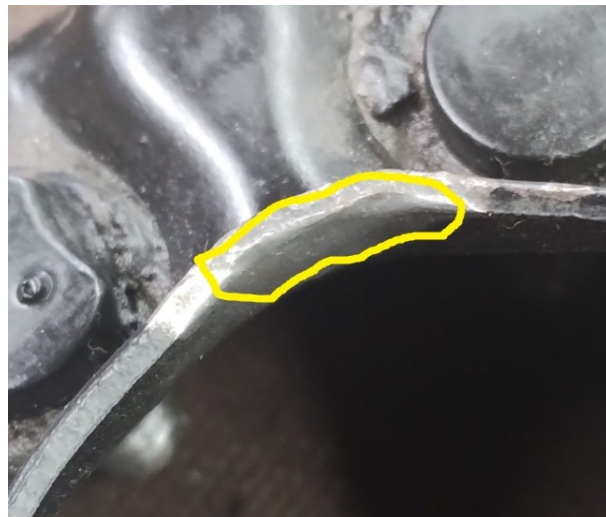
When stripping the front suspension, I found that the adjuster knob at the base of the shock had been damaged and realised that it had been making contact with the inner top rim of the spring pan during operation.

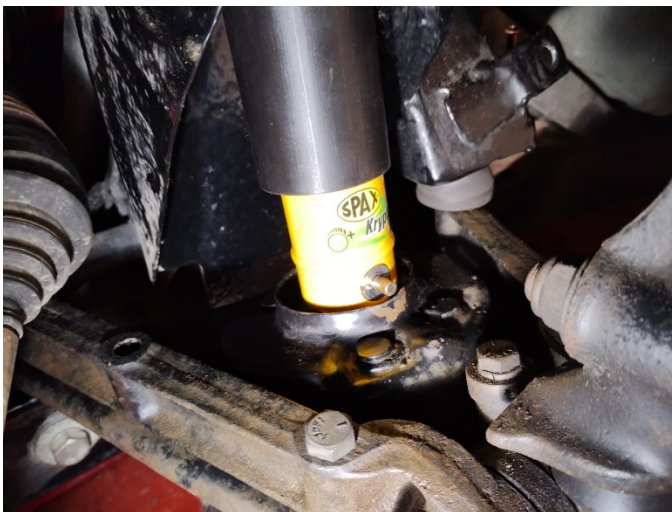
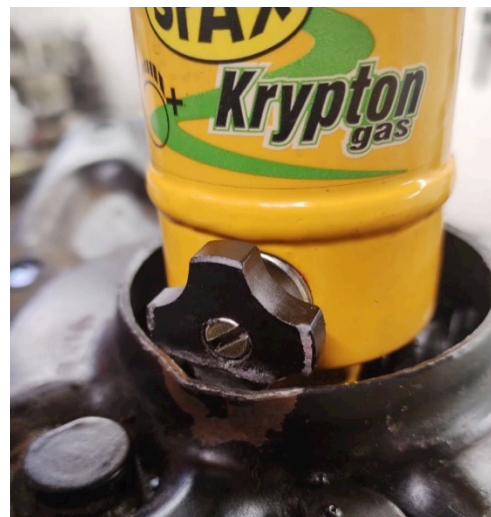
I suspect that the adjuster wheel contacting the spring pan had not only damaged the wheel, but the intermittent impact had compromised the security of the adjuster assembly in the body of the shock absorber. The bosses have very little thread and it is quite possible that if undiscovered, they could have blown out in service.

The picture of a shock absorber re-assembled to the spring pan without the spring clearly shows what is happening: when the suspension is under compression the knob contacts the spring pan. Even with the adjuster wheel removed it's far too close to the protruding adjuster screw for comfort leaving only a millimetre or so clearance. I've tried turning the shock absorber 180 degrees but this made matters worse.

Subsequent to further discussions with Spax they have agreed to convert a set of the dampers to the previously supplied standard, which features a shorter screw adjuster with no turn wheel. At the time of writing I am awaiting the return of the modified units.

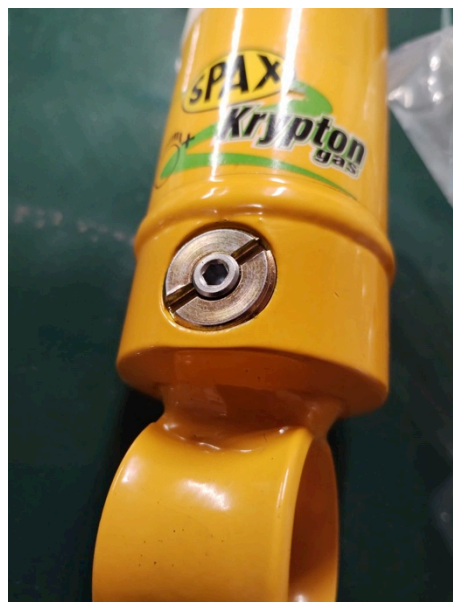
John has just received the modified shock absorbers back from Spax and was delighted to find that they had been fitted with a flush fitting adjuster with a hexagon socket. This will allow a ball ended hexagon wrench to be inserted between the spring coils and located in the adjuster at an angle without slipping.
