Jim Tully

April 2018

Jim is currently restoring a 1973 French blue British TR6 that he sourced from TR Enterprises in 1988, at the time trading in his 1972 damson TR6.

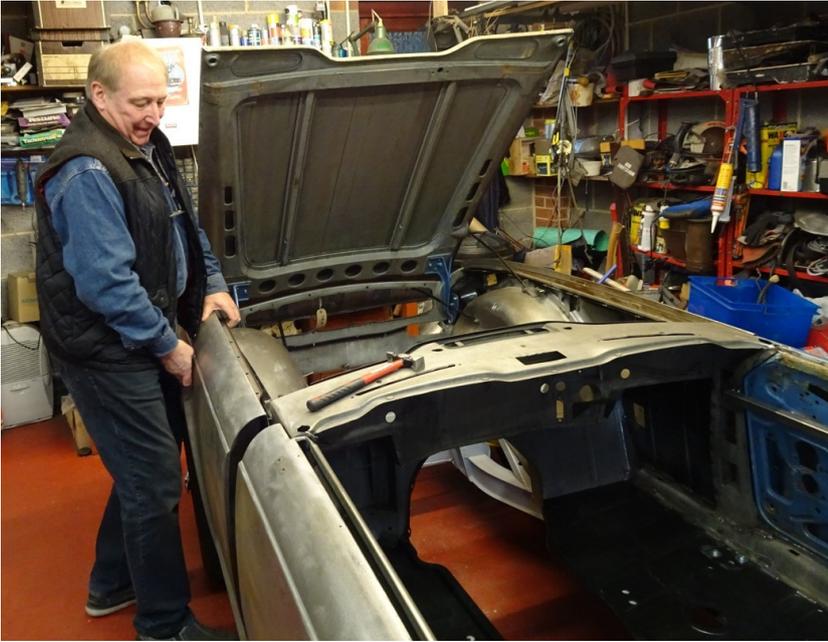
Jim checking the fit of the outer n/s front wing

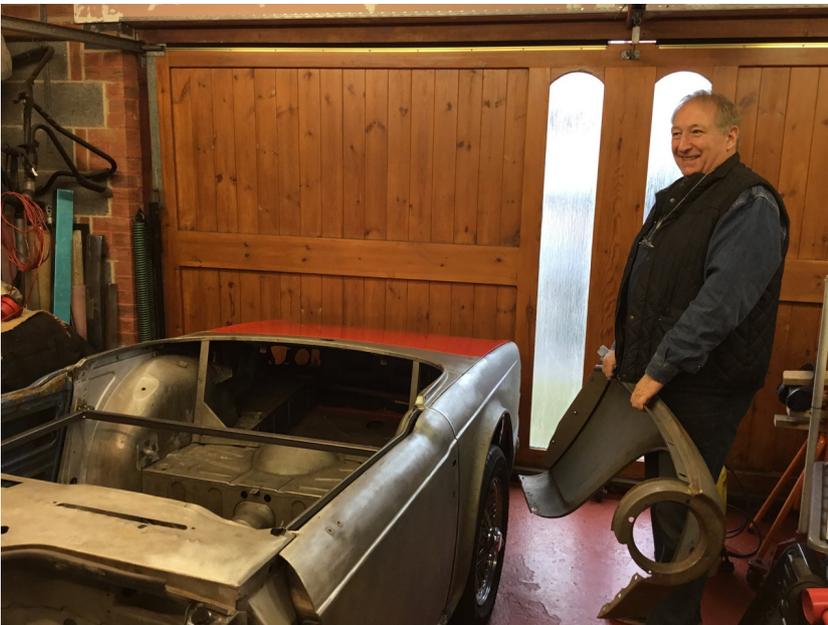
Rear view of body fitted to chassis

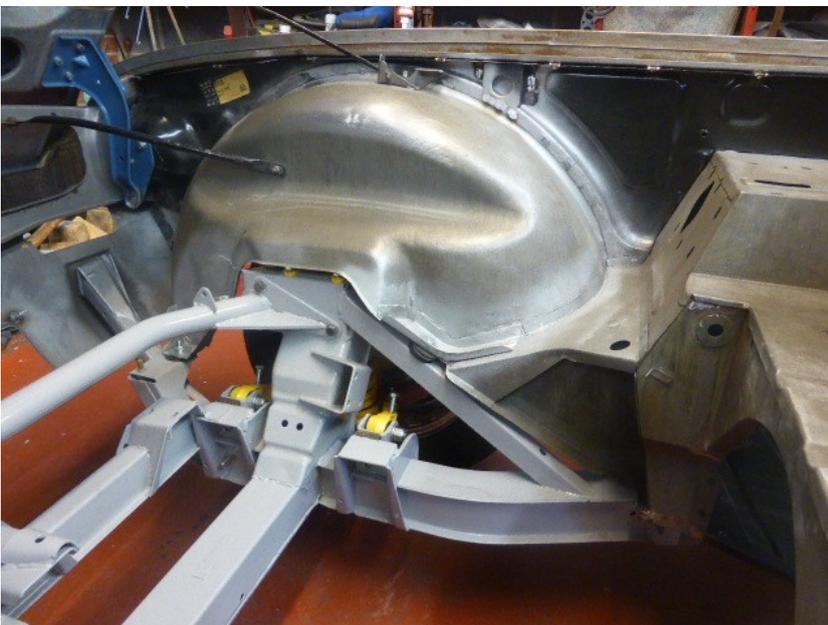
Heritage new front inner wings welded into position

The body was stripped and dismantled in October 2016. All four outer wings were found to be in excellent condition, and the wheel arches were fine. The front internal wings were replaced as these had been badly repaired. The inner wings are now heritage pressings. The rear inner wings have been replaced also. The original central portion of the tub was in good condition requiring only minor repairs. Both right and left floor panels have been replaced, along with the rear valance, both top and bottom using heritage panels. Jim has experienced some poor fit and quality problems with some panels he has ordered, where these have had to be returned. Heritage panels, however, have been a good fit.

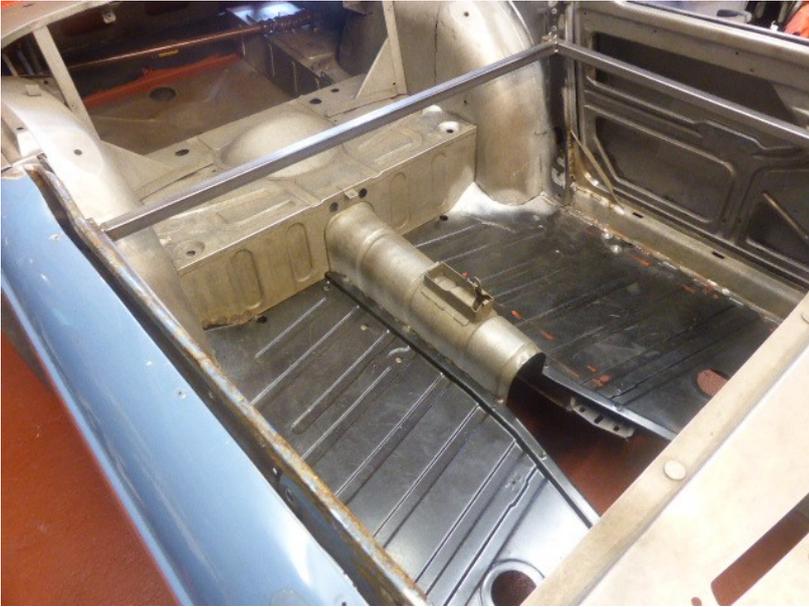
Bracing in position and new floor panels fitted

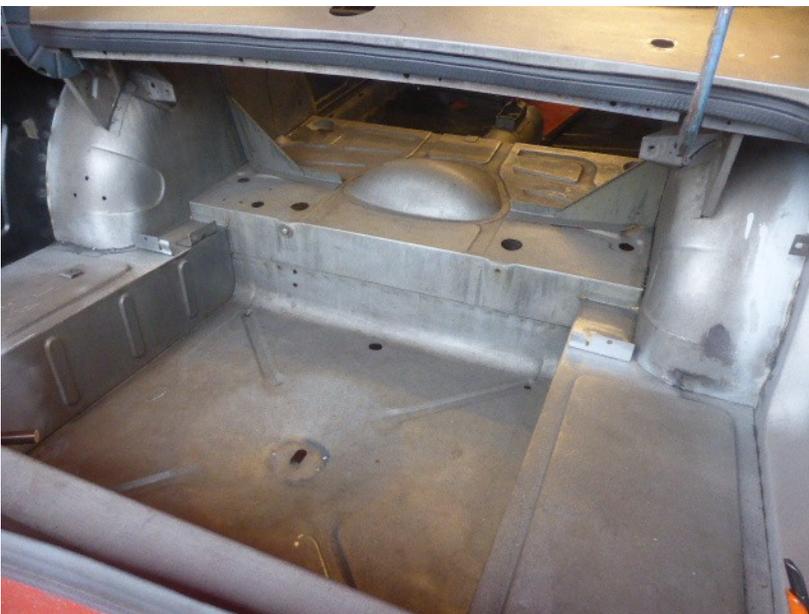
Boot with new inner wings in place
