# In The Garage

**December 2022**

Issue 16

### **TR4 Brake Refresh**

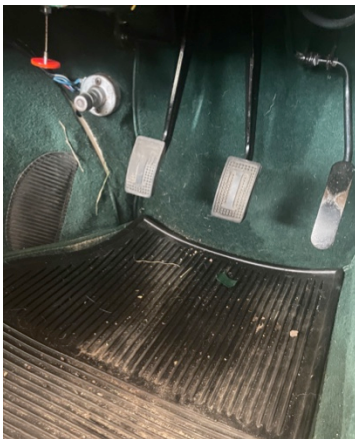
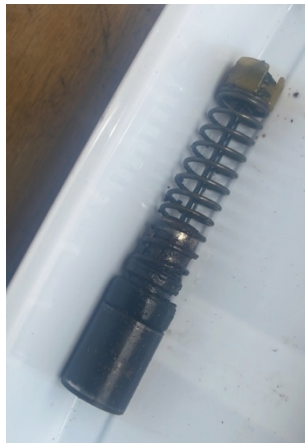
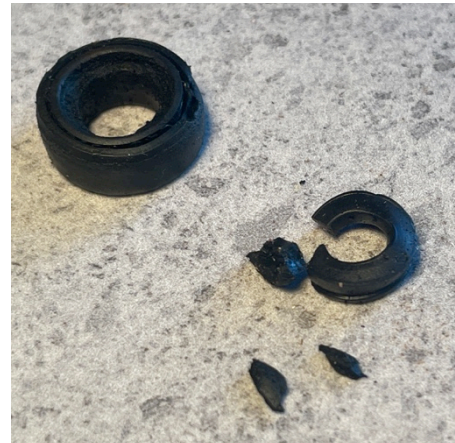
Fifteen minutes in the garage saw the master cylinder removed and stripped down on the bench. The problem was immediately evident; the internal seals broke up as they were removed!

The metal internals were showing some signs of corrosion too so all of the components were cleaned and blown through with an airline for inspection. Everything apart from the seals was re-usable so it was a simple job to rebuild the cylinder with a new TRW seal kit from my spares stock. The seals were lubricated with new brake fluid to aid assembly.

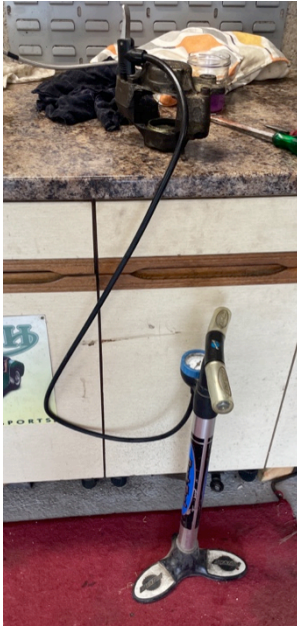
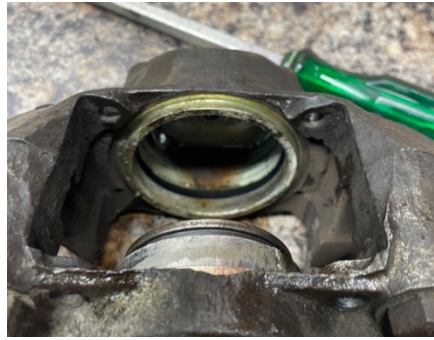
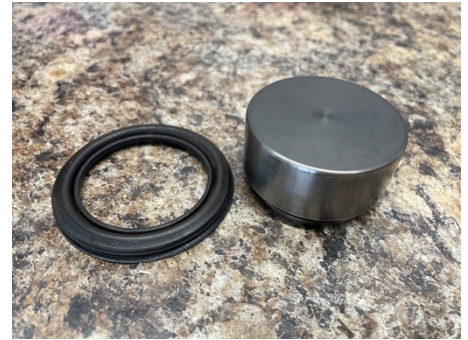
An hour and the obligatory cup of tea later both callipers and slave cylinders had been removed from the car and were out on the bench ready to be stripped down. The calliper pistons were quickly removed by connecting a bicycle pump to the bleed nipple and with the inlet port blanked off, a couple of pumps and a bit of jiggling popped them out.

The pistons and seals were in good condition with only slight corrosion evident on the outer edges of the pistons. The corrosion was quickly polished off with some steel wool leaving the pistons ready for re-assembly. The calliper bores were cleaned and the surfaces polished to remove some minor corrosion before being fitted with some new old stock Girling seals. The pistons were re-fitted with plenty of silicone fluid for lubrication. With new Girling dust seals in place the callipers were ready for re-fitting.

The slave cylinders were easily dismantled, cleaned and re-assembled using new seal kits and were quickly like new and ready for re-fitting.

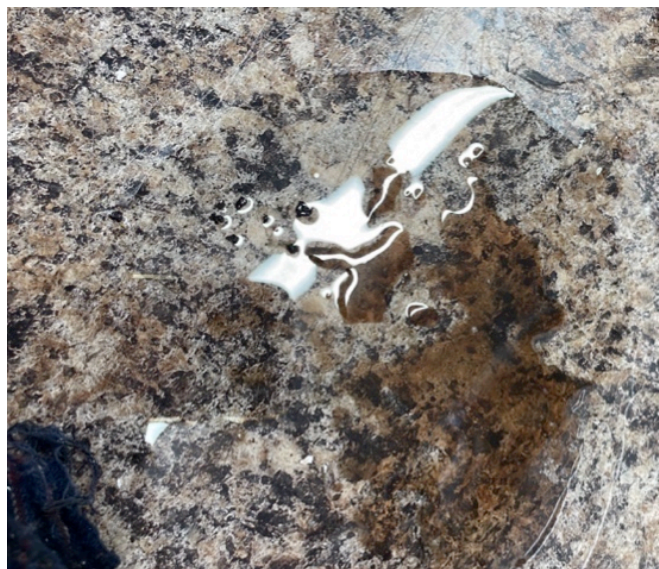
Water in the fluid was evident from the spillage on the bench, the discoloured water showing up distinctly against the clean purple tinted silicone fluid.

A disadvantage of using silicone fluid is that any water finding its way into the system through the reservoir breather will remain separate from the oil, promote corrosion and in the worst case can boil causing brake failure. Standard brake fluid will absorb the water, which will then be removed with a routine fluid change.

I've used silicone fluid for at least 40 years and never had a problem with it so I'll continue to use it but will strip out the callipers and clean them when I change the fluid. Standard brake fluid seems to strip paint better than the paint strippers available today and that's reason enough for me not to use it.

While the dynamic components were on the bench the brake lines on the car were blown through with an airline to remove any contaminated fluid prior to re-assembly.

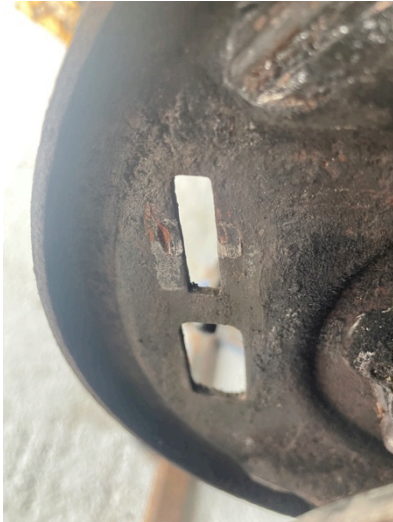
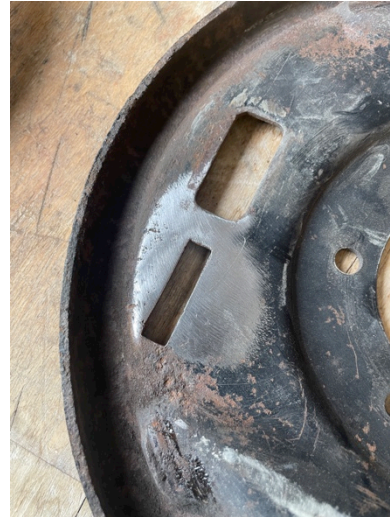
When the slave cylinders had been removed they revealed grooves worn in the back plates by the handbrake pivots. This is a common problem on all models of TR and the tried and tested solution is to weld up the grooves and flush them back with an angle grinder. It can be done on the car but it's a lot easier on the bench so the half shafts and hubs were removed as an assembly to release the back plates. John Blake did a great job of welding and flushing them back for me and they were given a light coat of paint before building everything back up and checking the half shaft end float. As I had been careful to make sure that the shims had gone back in their previous positions, and that the back plates were left with not much more than overspray on the mating surfaces, I found that the half shaft end float remained within tolerance.

With all the component parts now refurbished everything was fitted back to the car. The only thing which some may find problematic is the re fitting of the clips and gaiters around the slave cylinders. There is an excellent guide to this process on the TR Forum that will save me a lot of typing. It can be found here:

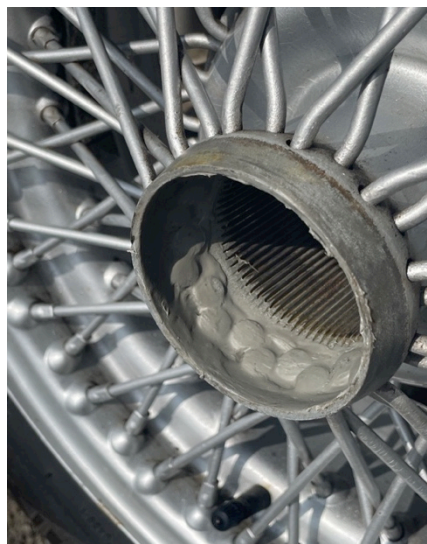
Cleaning wire wheels is not the easiest task at the best of times but it can often be made more onerous by grease migrating up the spokes towards the rim from inside the hub.

Having spent some time cleaning the wheels on the TR3 I went the extra mile and degreased the inside of the hubs prior to treating the heads of the outer spokes to a smear of body sealer. This simple measure has cured the problem.

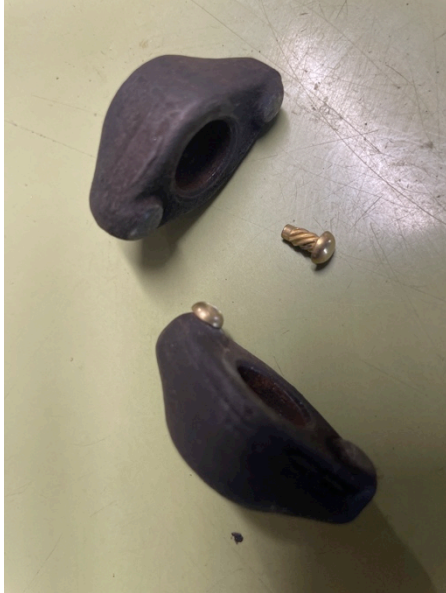
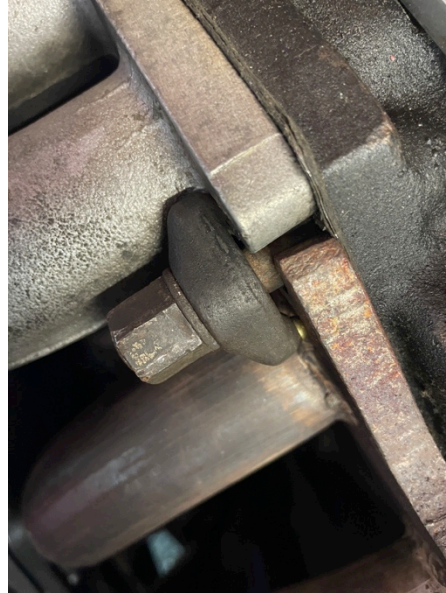
Many of you will have fitted aftermarket exhaust manifolds and most will have found that the replacement manifold has a thinner flange than the standard cast manifold making the fitting of the clamps problematic. Some leave the clamps wonky, which can bend or sometimes break a stud off in the head; others weld extra material onto the clamp or the manifold flange to make up the deficiency. I had a box of drive pins in the garage so it was a simple job to drill the clamps and press in a pin to one side of each clamp.

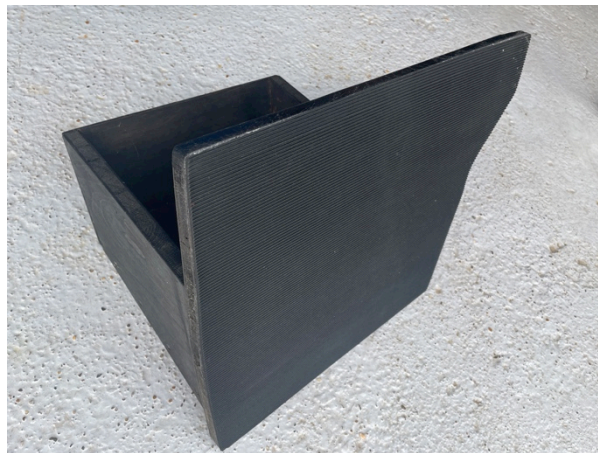
This third iteration was made from 18mm blockboard and features a tool storage bin and higher footplate that conceals anything stored behind it from all but avid speleologists. For our trip to Classic Le Mans the bin housed the tool roll and an emergency starter pack with a box of wine and a box of cider on top ☺.

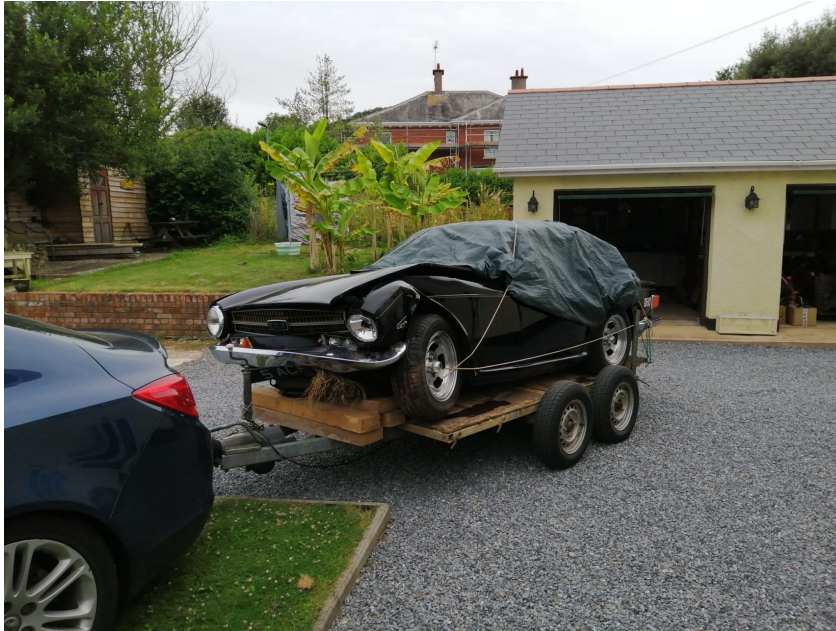
Last year, on his way to a Devon Group picnic meeting, through no fault of his own, Mark had what equestrians might term an “unscheduled dismount” which resulted in a ride home in a recovery truck and subsequently buying his well regarded black TR6 back from the insurance company. A course of action regarded as a bold move by some.

Mark started his new project on the same day that he recovered the car back to his workshop, stripping parts off and assessing the damage while formulating a repair strategy as he went. He found that the first part of his plan was a lot easier than he had imagined as was able to find a replacement car within the Devon borders to use during the restoration and buy him some time. The car was finished in white, a considered choice.

With a little help from other group members the car was soon reduced to a bare chassis and the real damage was revealed. The chassis ahead of the crucifix section was badly twisted, crushed, wrinkled split and lots of other words which would discourage most people, but not Mark.

There was little chance of straightening the damaged sections so the disc cutter was pressed into action and the offending parts were cut away leaving the surprisingly straight and rust free rear end ready to accept new repair sections. The undamaged suspension turrets and various other minor brackets were all cut away from the damaged sections and fettled ready for re assembly. A local fabrication company were pressed into service folding new sections for the replacement chassis legs and internal strengthening webs.

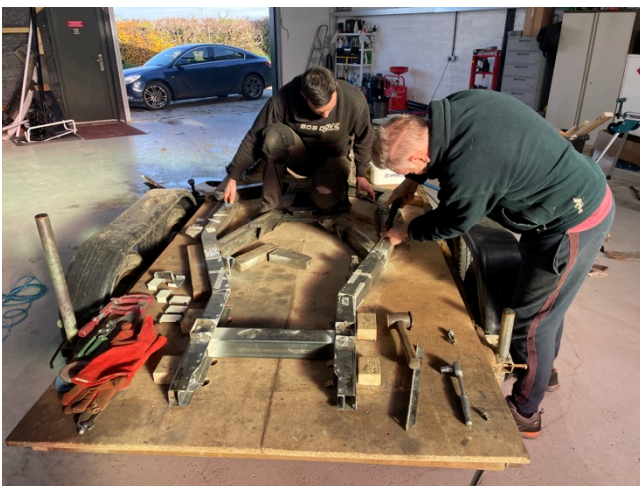
*The chassis being fitted and aligned in the jig.*

An assembly and alignment jig was made from made from some sheets of OSB mounted on a wooden frame and with reference to the dimensioned chassis drawing in the workshop manual and the aid of a laser level and tape measure the rear section of the chassis was bolted down and blocks fitted to correctly align the new front sections. It sounds like it may be Heath Robinson, however the results are anything but. When ready for welding the new sections were all well within half the original factory tolerance of + or -2mm at the cost of some weeks of hard graft.

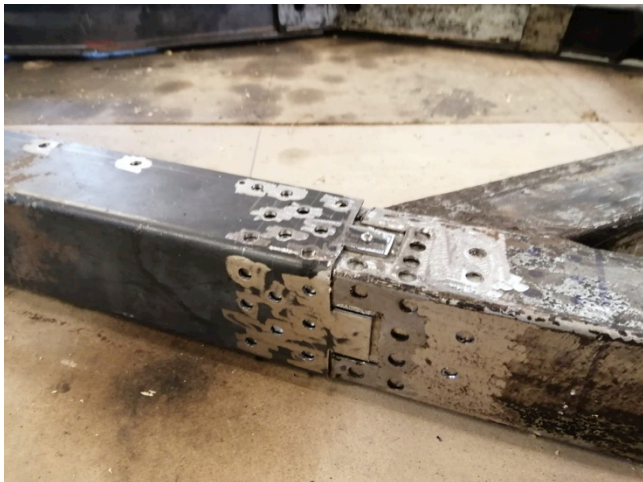
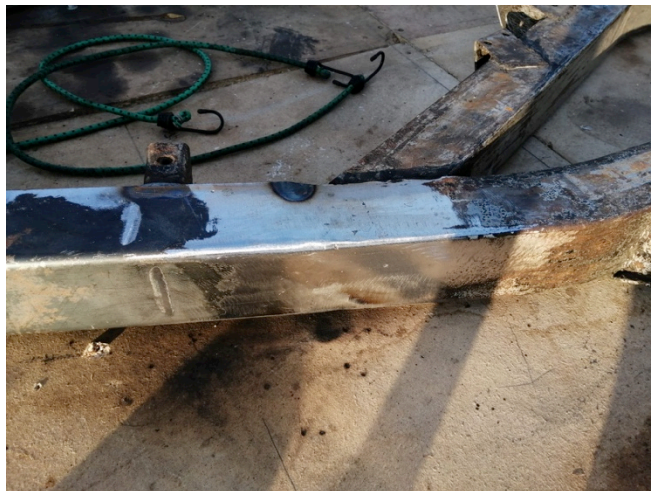
The photos below show one of the two critical joints where the old joins the new. The holes were all plug welded through to an internal sleeve and the seams fully welded prior to flattening back for a very strong and invisible join.

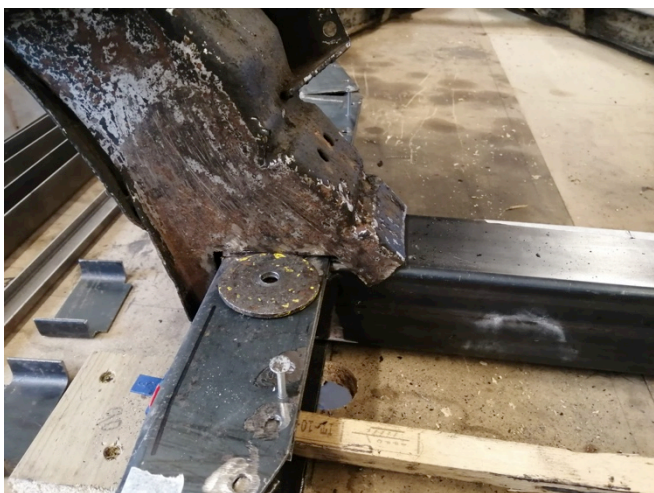
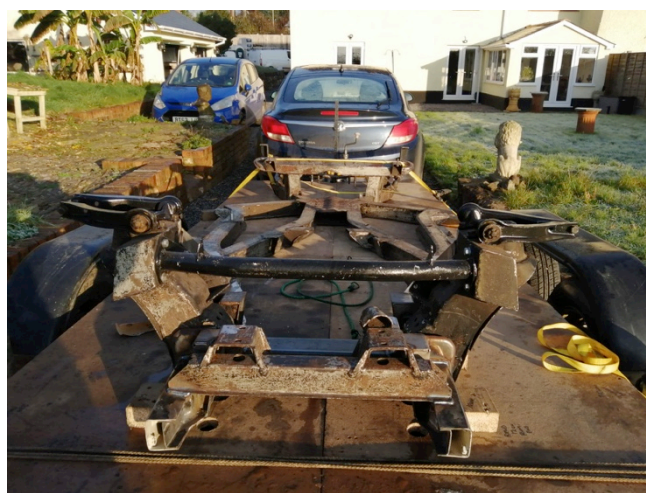
The old turrets ready to be welded to the new legs and cross member and the completed chassis fully welded and back home ready to act as the jig to rebuild the body shell.

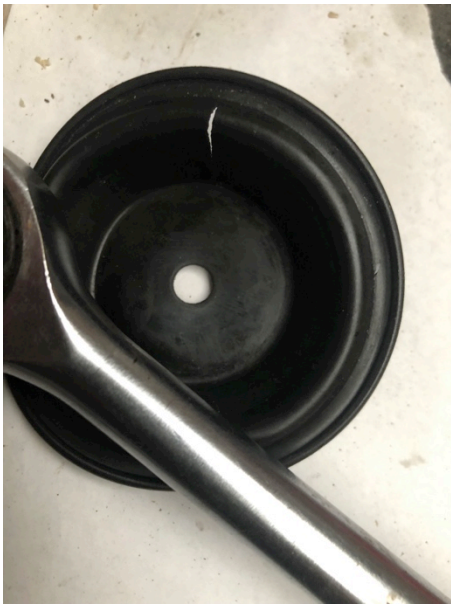
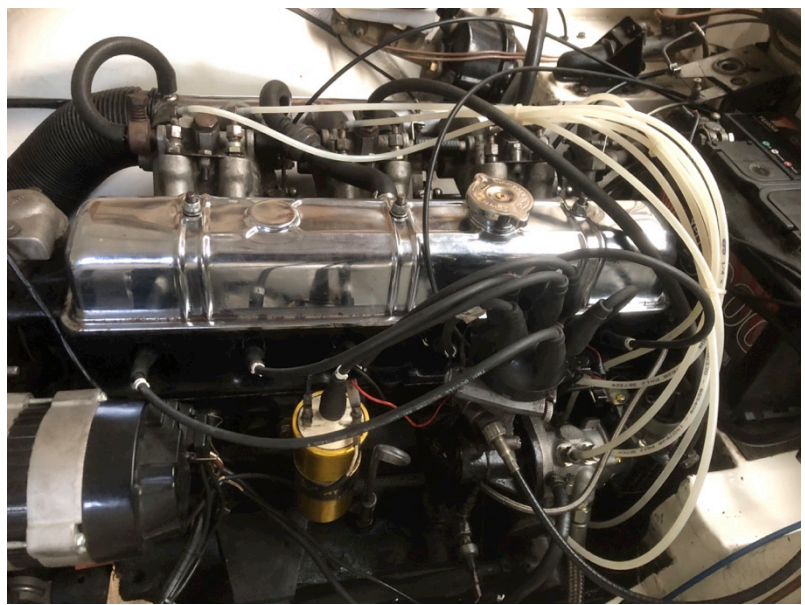
As usual Steve has been racking up the miles in his TR5 this year, attending lots of shows and keeping the TR profile high. He had noticed a marked increase in fuel consumption and resolved to investigate and find the cause. After a fruitless search for leaks, checking the timing and valve clearances Steve focused his attention on the metering unit, which had provided good service for at least 15 years without attention. A few minutes work exposed the rubber diaphragm and close inspection revealed a split.

A new diaphragm was ordered and fitted together with a set of translucent nylon injector pipes, which allow quick diagnosis of air in the system when the six cylinder engines drop onto five cylinders and one needs a quick roadside bleed.

Note also the new oil filler cap to replace the original which went astray when a local garage changed the oil; it's always worth a quick check under the bonnet after a service and before driving off!

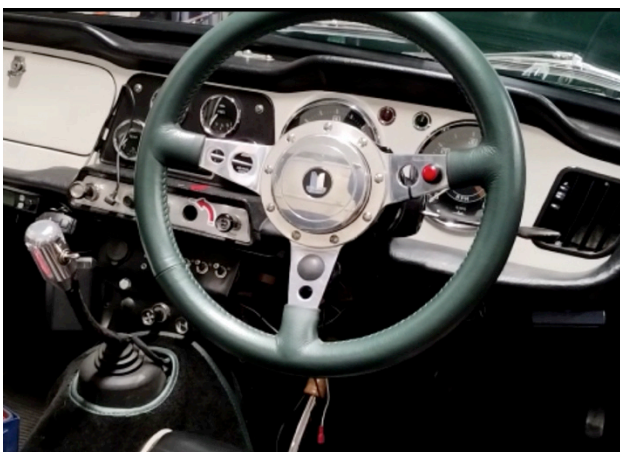
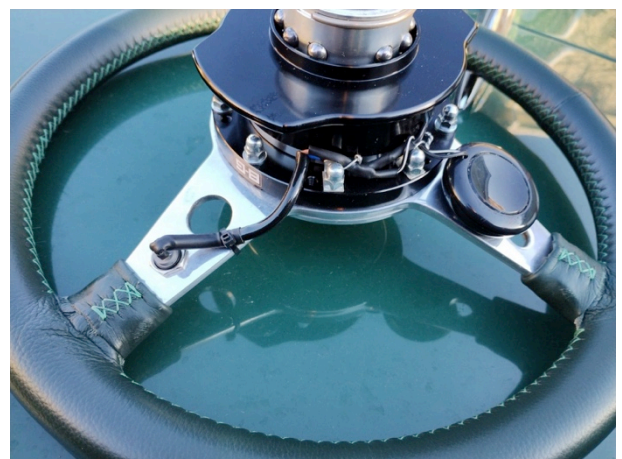
The problem came when he also fitted a quick release steering wheel boss which when removed remained tethered to the car. An online search found a wireless button and receiver, which was ordered and quickly delivered. The receiver unit was mounted under the dashboard and connected to the logic unit and the button clipped to the steering wheel. Trials bore good results but the button was overly large as it contained the battery and electronics for the sender. A bit of ingenuity allowed the wireless button to be mounted behind the wheel with a short cable connected from the internal electronics to the button previously mounted to the hole in the spokes. John now not only operates the overdrive from the steering wheel button without the coiled cable but is also pleased to demonstrate that it still works when he is outside the car with the wheel in his hand ☺
