In The Garage

Sept 2023

Issue 18

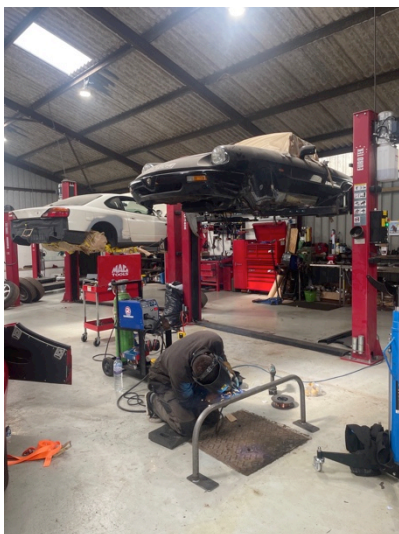
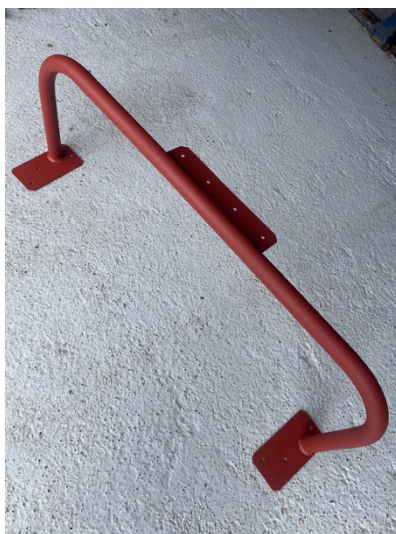
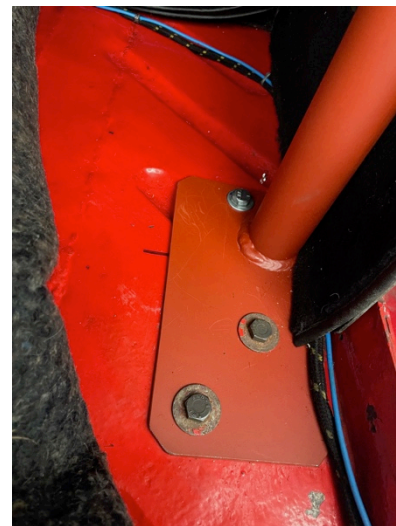
Footplates were cut from 3mm thick plate together with a plate to secure the centre of the bar to the underside of the battery tray.

Once the components had been test fitted the car was driven to the Bob Dove Motorsport workshop near South Moulton and Mikey Dove quickly tacked everything in place. The whole assembly was then removed which was easier said than done but it did come out using some Chinese puzzle skills. Mikey then finished welded it and it was taken back to the garage for a quick coat of Bondarust primer before being refitted to the car and bolted firmly in place.

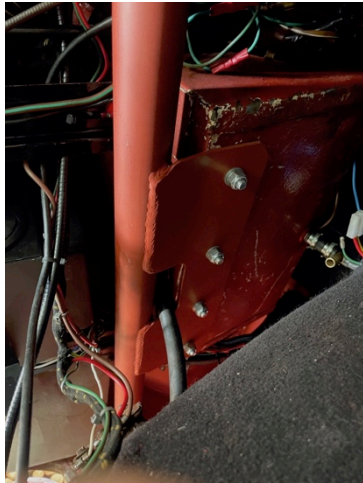
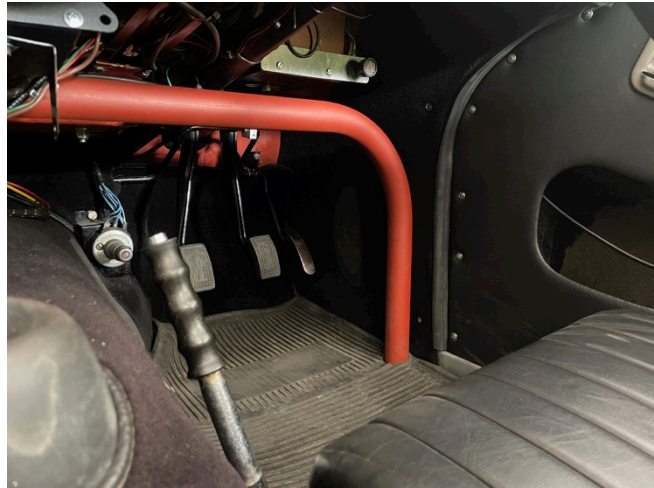
With a couple of 38mm holes in the carpets and the overdrive relay replaced with a modern unit in the relay bank under the bonnet, the car was test driven along my back roads test route and revealed that all traces of scuttle shake were absent and that the ride seemed considerably quieter; a great result.

The new brace will provide a good bit of extra impact protection around the foot-well and form the starting point for the future installation of door bars linking to the roll bar at the rear.

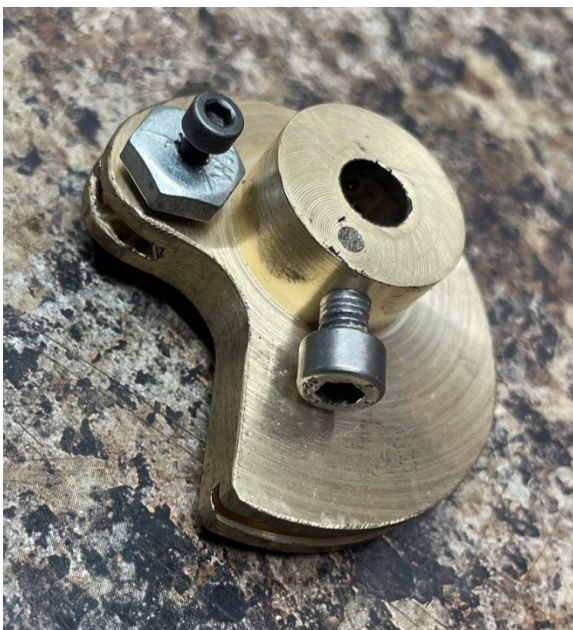
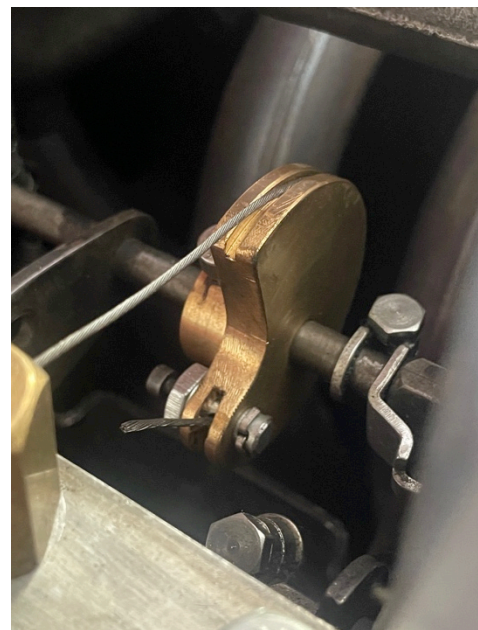
A few hours in the workshop saw a brass quadrant ready to fit. The initial cable pull acts on the larger diameter that rapidly reduces as the throttle is applied so that the first half of the pedal movement translates to about one quarter of the carb opening and the second part then opens to full throttle.

Road testing revealed an improvement but I may try a more pronounced cam to increase the progression.

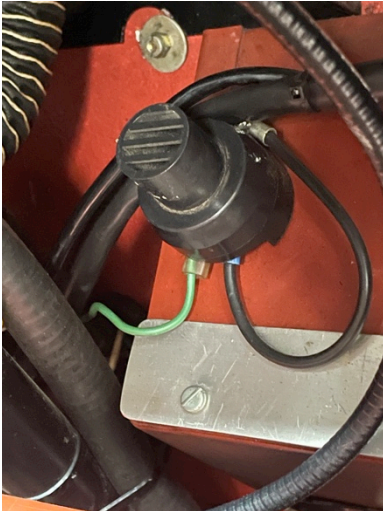
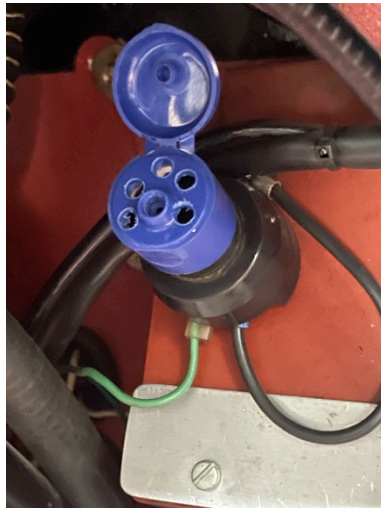
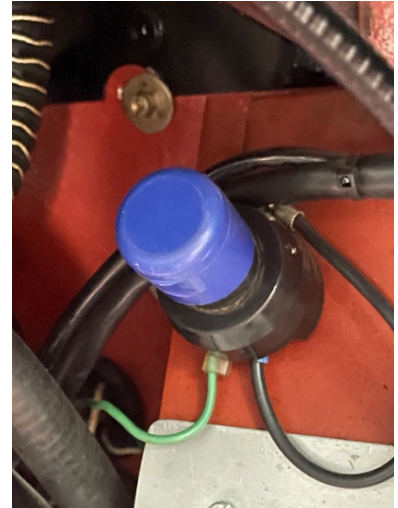
I don't think that this item will be much help to anyone else but I found it amusing and useful. Anyone who has travelled in close proximity to my TR3 will be familiar with the sometimes overly loud indicator audible warning. The usual solution has been to stick a piece of tape over the sounder. This is fine around town but renders it inaudible when at speed on motorways and dual carriageways so it usually gets ripped off and replaced later. I'm sure that electronics gurus would soon sort out a variable volume control but my mind doesn't work like that so a much less technical solution came to mind using a squeezey bottle top.

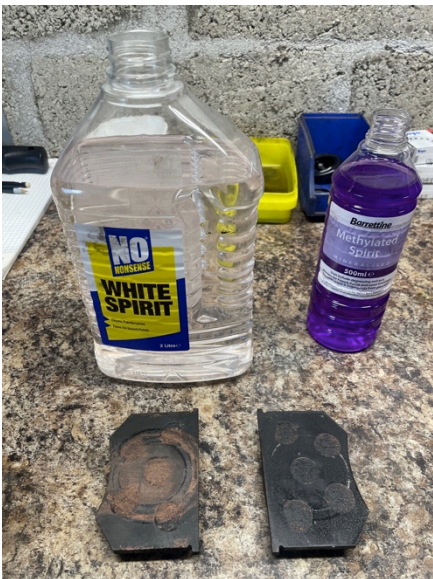
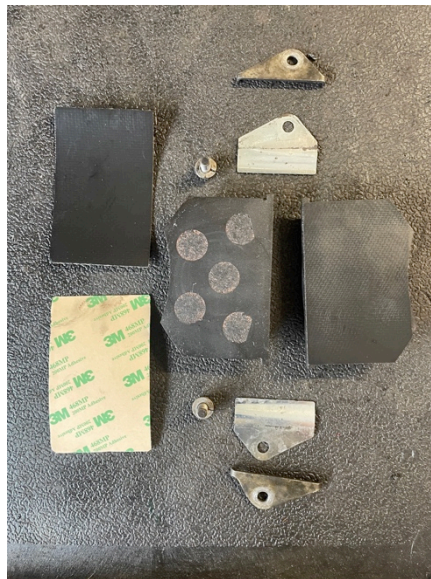
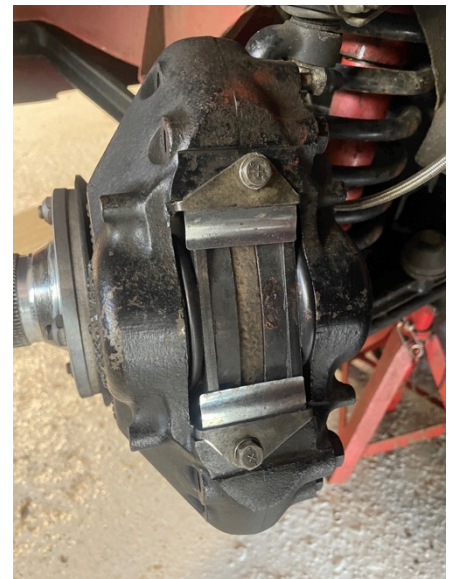
I recently replaced the Mintex M1144 brake pads on the TR3 and quickly found that the new ones although effective tended to squeak and squeal. I'd had good results before using 3M anti squeal pads so a set was ordered online from brake specialists Bigg Red who keep genuine 3M items in stock. With the pads removed the steel backing plates were cleaned with white spirit and then methylated spirits and the self-adhesive pads were stuck in place before being trimmed to size with a craft knife. Having been marked on removal, the brake pads were re-installed in their original positions. New anti rattle springs were used for good measure.

No squeaks or squeals have been evident since and there is no noticeable difference in the pedal feel with the extra layer in place.

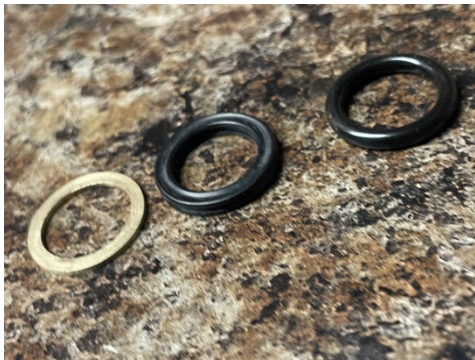
I managed to source a modern Quad seal that provide a double seal and more flexibility than the O-ring to cope with any misalignment. Some brass back-up rings were made to take up the slack in the recess and prevent movement. A commercial nylon back up ring could be used in its place.

Back up ring, Quad seal & O-ring

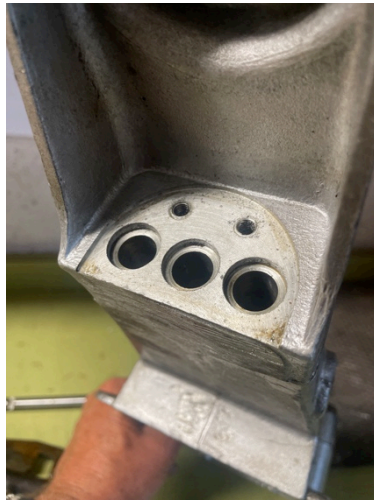
1. The standard O-rings that seal around the selector shafts are free to move longitudinally in their oversize recesses, this can cause a "pump" effect due to seal roll back, sometimes sometimes specified to lubricate the seal.
2. The 3rd and 4th gear selector shaft features a small through hole that transmits the seal during operation and carries a small amount of oil with it each time. Research suggests that this may be to lubricate the area where the rods slide against each other.
3. An O-ring only makes a single line seal on the shaft, which can be improved.

Seal recesses

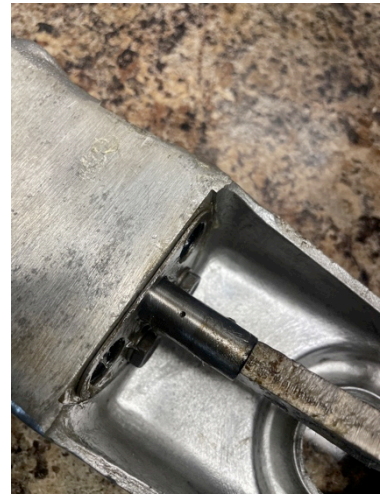
The hole in the centre shaft was filled with J B Weld and polished back and the shafts were greased where they slide against each other.

Hole in the centre selector

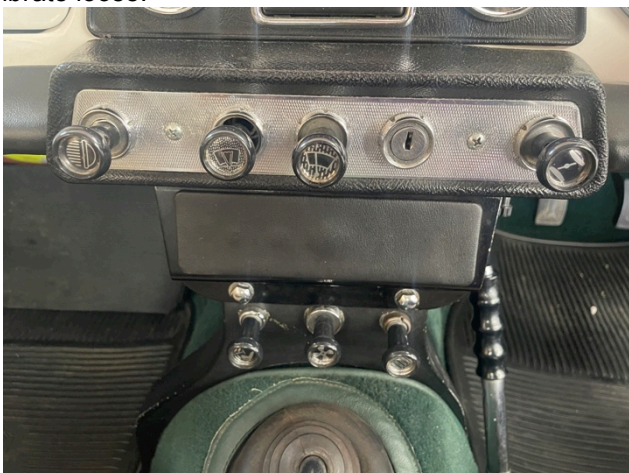
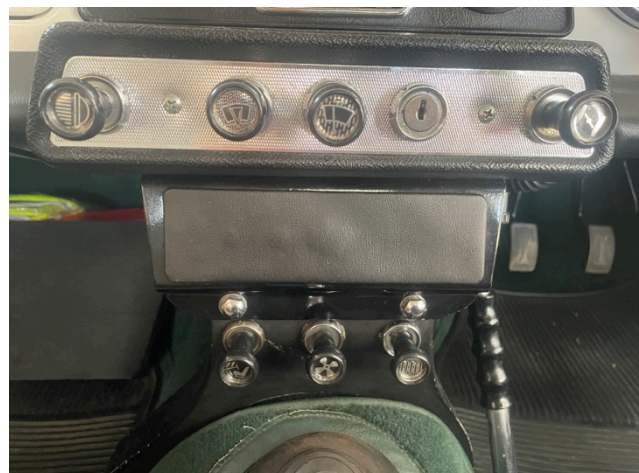
TR4s are fitted with unique switch bezels to add a bit of bling to the switch panel but knobs for the cable operated heater controls have a different thread pitch and so are fitted with the uninspiring standard chrome rings. The switch bezels are thin and only accommodate two or three threads so a bit of fettling on the lathe soon had some spare bezels close enough to screw onto the cable pull bodies. A suitable spacer was fitted behind the H frame to allow only minimum protrusion of the threads and the bezels were fitted with a drop of Loctite to make sure that they don't vibrate loose.

Spot the difference

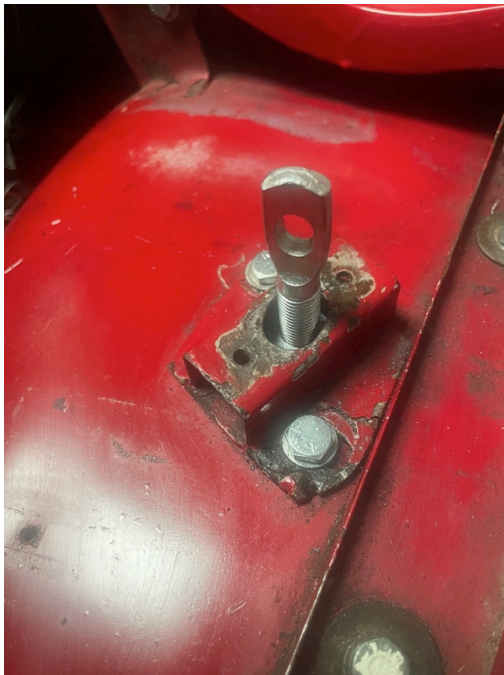
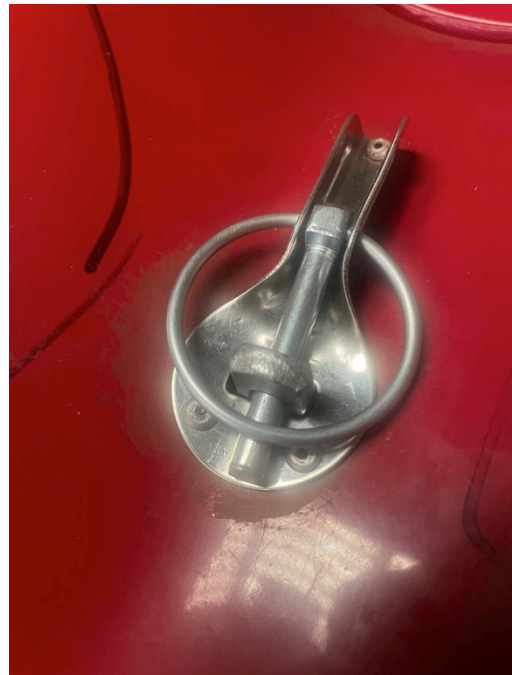
The springs were removed from the standard receivers mounted on the inner wings together with the Dzus cams in the bonnet and with the bonnet closed holes were drilled down through the cam holes and straight through the inner wings. The new latch pins were bolted through the holes secured with large, load spreading washers and a couple of lock nuts each.

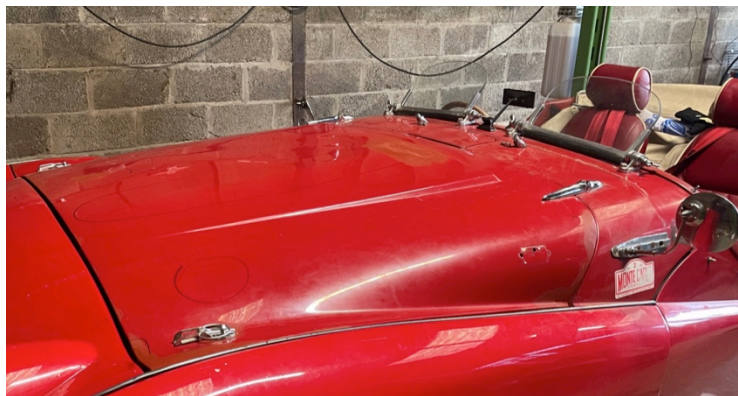
The latch plates required a little fettling to fit the profile of the valley in the bonnet but once all was well they were locked to the pins now protruding through the cam holes and pop riveted into place.

The completed modification looks entirely in keeping on a modified car and not only ensures that the bonnet will remain in place but has the advantage of not needing a budget key to open.

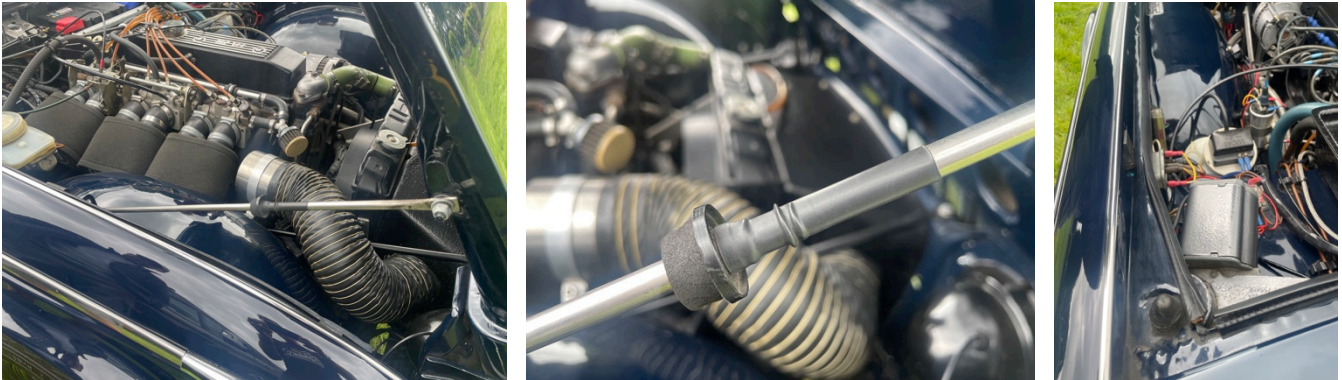
A soft buffer is secured to the bonnet stay and compresses against the stay guide when the bonnet is closed. A lip seal is fitted to the rain gutters on each inner wing and seats against the closed bonnet.

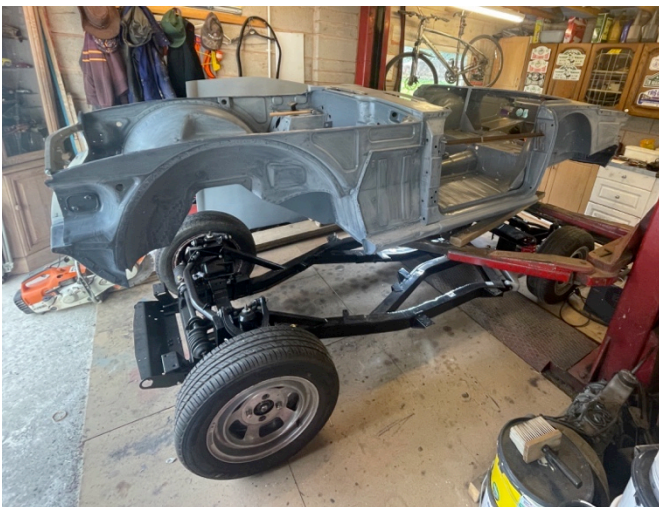
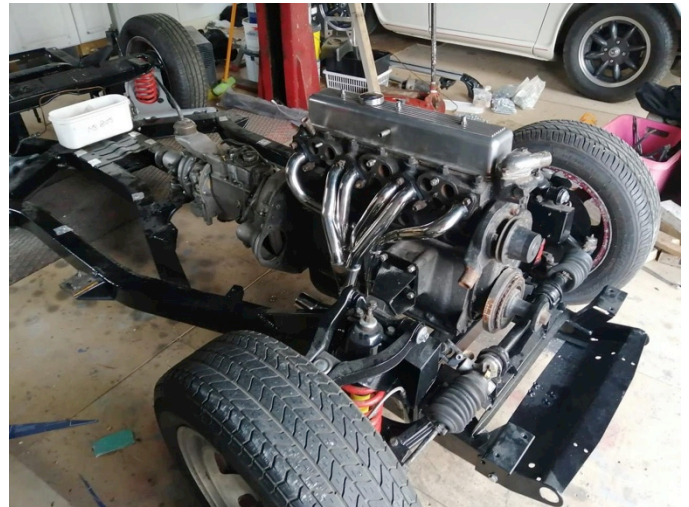
Mark's rebuild continues. My latest visit found the suspension and steering all fitted, the body complete and ready for paint.

A week or so later the engine, gearbox and shiny new exhaust manifold were all fitted. I'm looking forward to seeing the car back on the road next year.

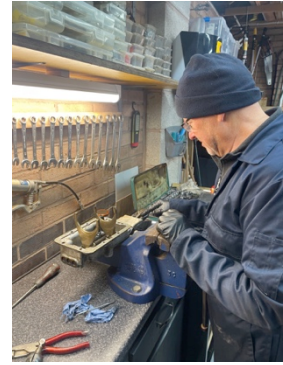
Martin found himself waylaid at the roadside early in the year unable to select any of the TR6's four gears. The car was quickly recovered back to his garage and the familiar Gearbox Party was organised with volunteer group members assisting the gearbox removal ready for a detailed examination. An oil leak from the bell housing had been on the jobs list for some time and this would be investigated at the same time. The initial problem was quickly identified. The anti rattle plunger in the base of the gearstick had become displaced and had jammed the change mechanism.

A new spring and plunger was ordered ready for re-assembly.

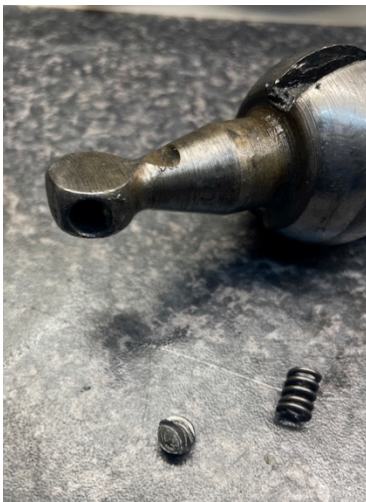
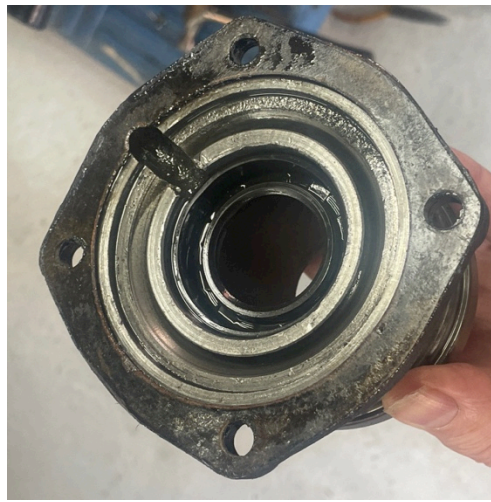
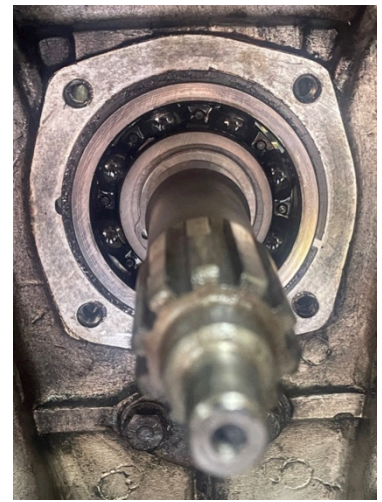
With the gearbox removed it was evident that the oil leak was coming from the gearbox input rather than the crankshaft seal. This was easily remedied by fitting a new seal and nose gasket, generously donated from John Blake's extensive stock. The gearbox nose/clutch release-bearing carrier allows fitment in four different orientations but should always be fitted with the oil gallery at 9 o'clock to line up with the recess around the main bearing. Like many, Martin's was not lined up when disassembled.

With the gearbox on the bench the top cover was removed so that the internals could be examined and the selector shaft seals replaced. The overdrive was also removed for partial strip and examination. No damage or wear was evident and the clearances were in tolerance, so the transmission was re assembled with new gaskets brushed with a light coating of Welseal to cure a couple of nagging oil leaks.

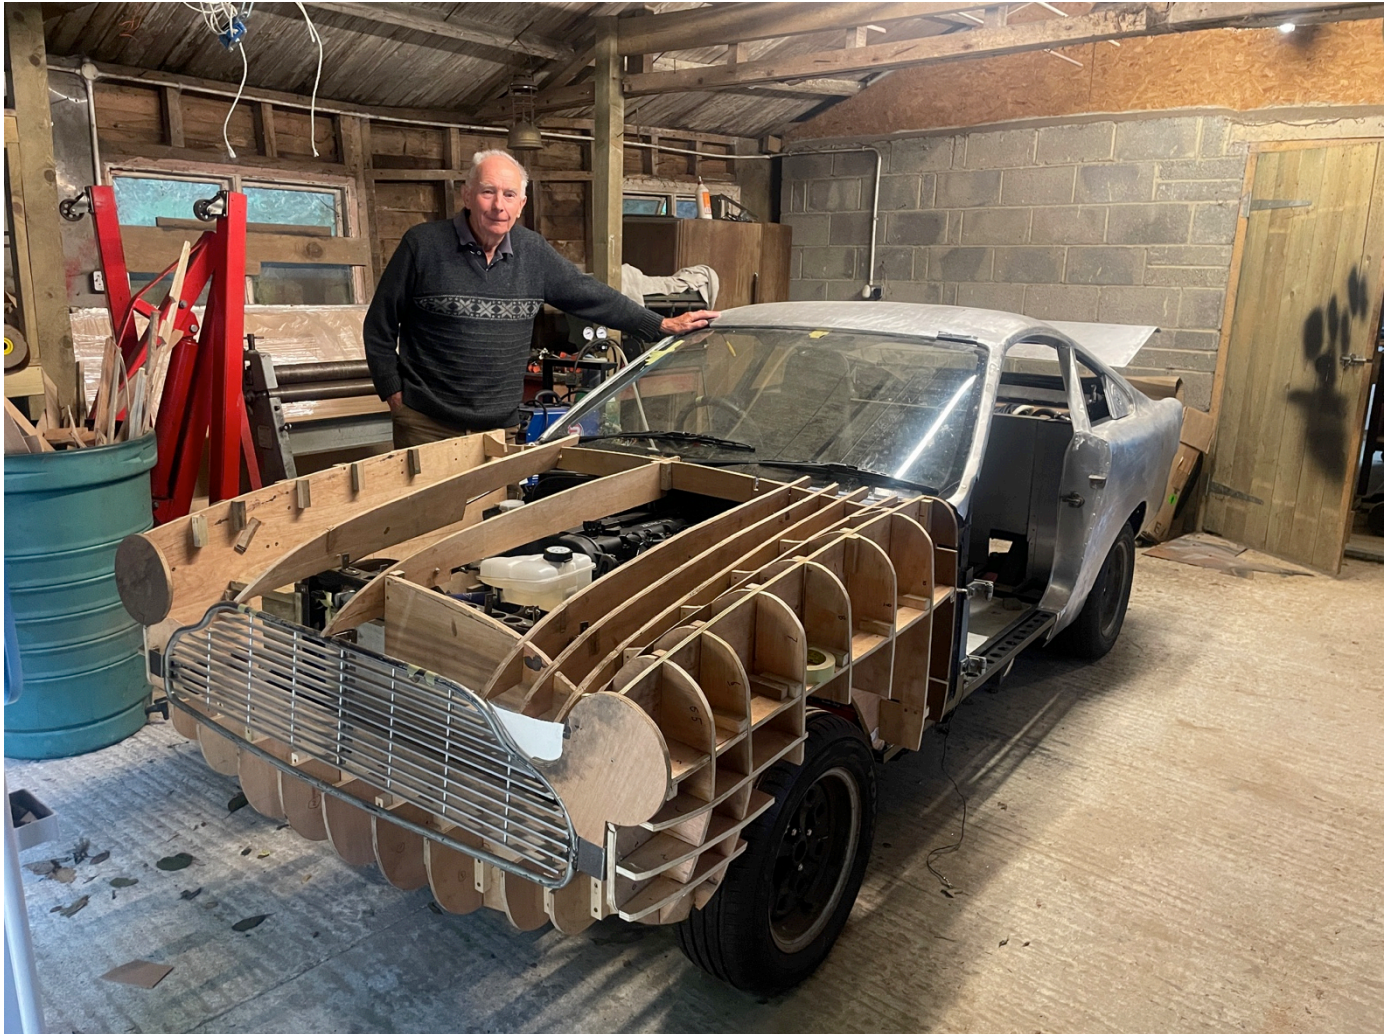
Although not a TR, I think that most will be interested in John's latest project, which takes up his time when he is not driving his striking yellow TR3. I called in at his workshop recently and got the full rundown on his unique special. Based on a Reliant Kitten chassis. The compact coupe features a Ford Zetec SE engine, which is fitted with Jenvey throttle bodies and EFI. The all aluminium SE, or Sigma engine, was developed with Yamaha and weighs a mere 80kg. The dash support/scuttle is taken from a Fiesta as are the front and rear screens, although this is not at all obvious to the casual observer due to the far from Fiesta like angle at which the glass sits. John has used his carpentry skills to produce the wooden bucks and is fabricating the self-designed bodywork from sheet aluminium.

To my mind the lightweight body references a number of classic 70s design cues with its Aston Martin style grille and Trident Clipper like rear three quarters.

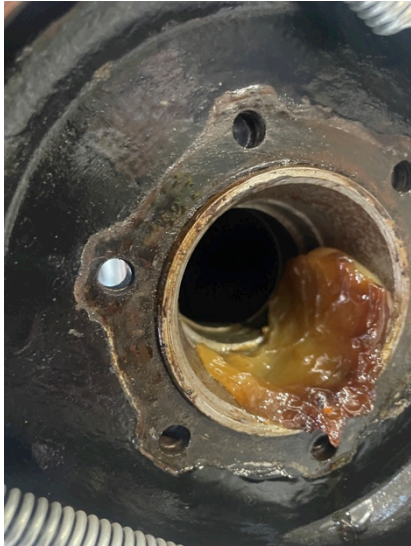
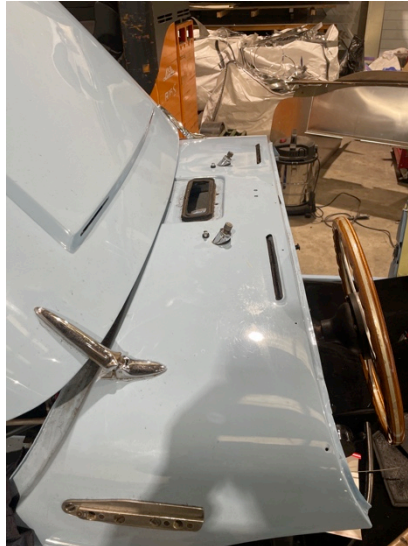
I was recently able to assist with a TR3, which had been rebuilt by a general garage rather than a TR specialist. It was dripping oil from its rear brake drum. Removal of the half shafts revealed that the inner seals were not just leaking but were completely absent!

See if you can spot another problem on the same car in the second picture :-)

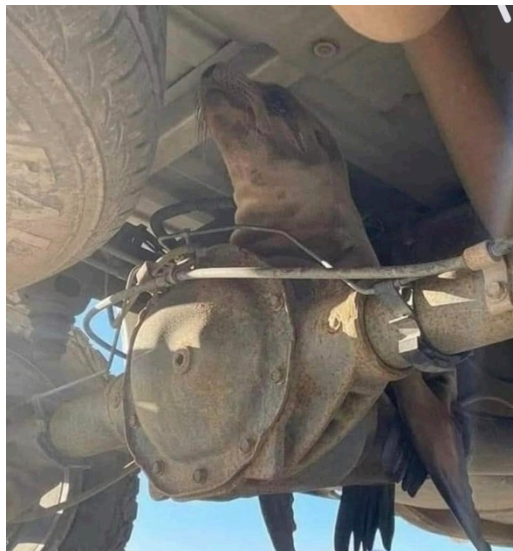
...and finally here's a different axle seal problem.
