In The Garage

Feb 2024

Issue 19

Andrew Willmott – TR3 and TR4

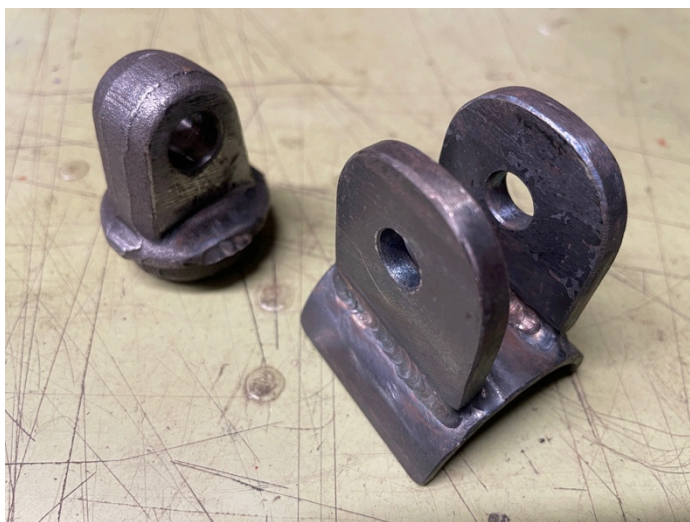
A forged OMP lug with the home fabricated fork.

Following on from fitting a sturdy scuttle brace (detailed in issue 18) the next stage was to manufacture a pair of door bars running from the scuttle brace to the base of the roll bar. It was decided to make the bars a bolt on fit so that they can be easily removed should access become difficult as the years catch up. To that end weld on forks were made to fit to the roll bar and scuttle brace. Matching FIA approved lugs were sourced from OMP: making them really wasn't worth the effort.

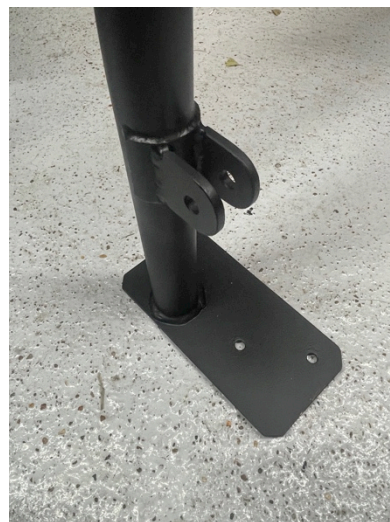
Fork welded to the scuttle brace.

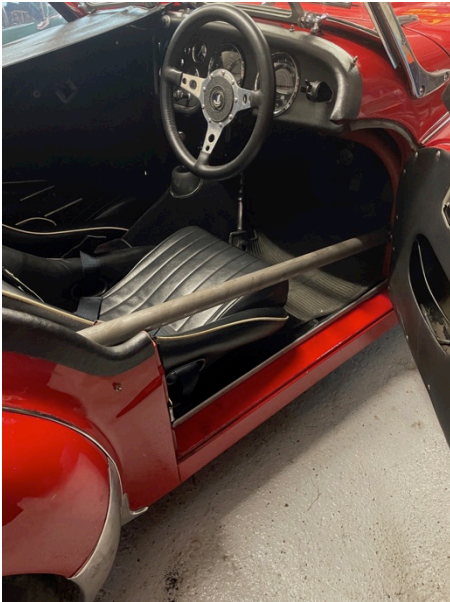
The drivers-side door bar mocked-up in place.

As before with the scuttle brace, the bars were mocked up with plastic waste pipe before being bent up in 38 x 3 cold drawn seamless (CDS) tube. The forks were then temporarily screwed in position and once the whole assembly was jiggled up in place the lugs were welded into the ends of the bars. Space between the door and seat is very limited and this dictated the lie of the bars. With the whole assembly in place I took the car on a few journeys to ensure that access and egress were not unduly impeded and that the bars didn't get in the way whilst driving. Once all was tested and approved by "The Boss" the whole lot was removed for final welding.

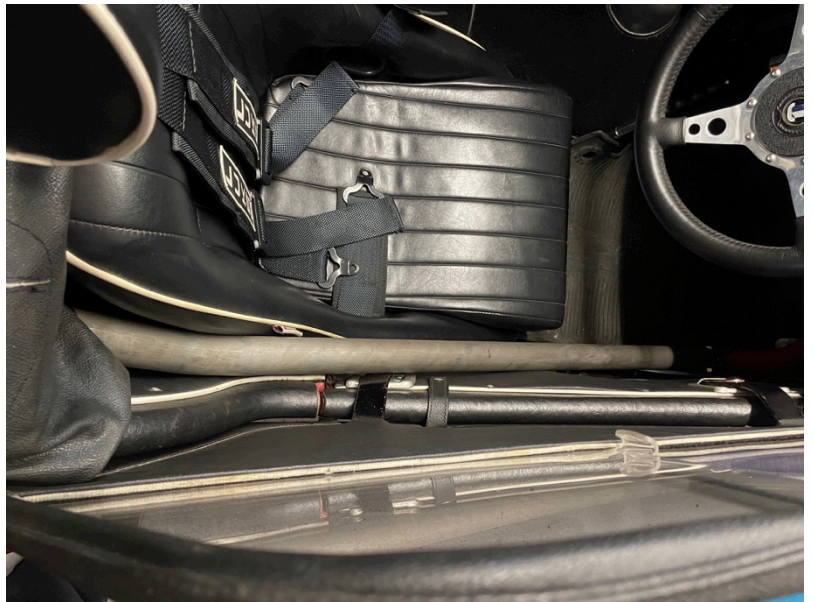
Routing past the seat, avoiding the door and side-screen mounts is tight.

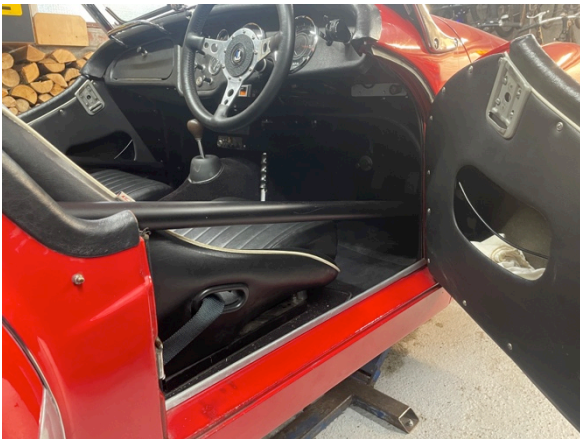
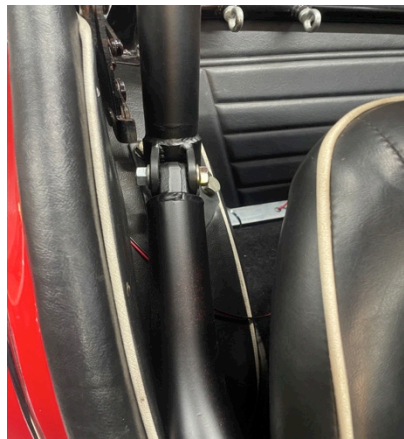
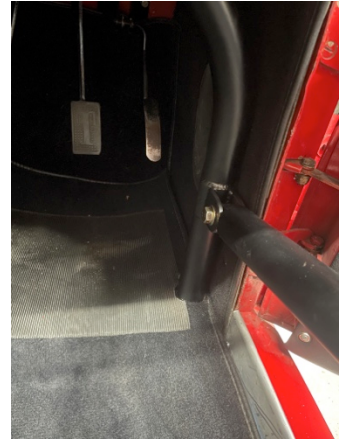
A quick coat of black paint was applied before re-assembly.

On the road the car is now noticeably stiffer with fewer rattles and although not up to modern standards we have now greatly improved the side impact protection. Although much of the door aperture is now covered by the door bars access is not unduly compromised and anyone who wants to try out the cockpit is welcome to try it for size whenever the car is seen out and about.

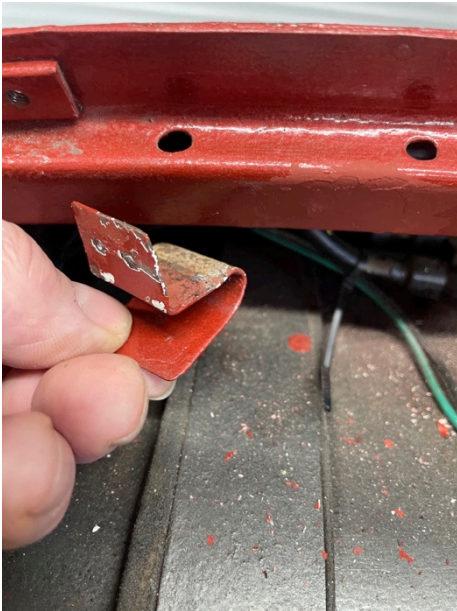
Trim clips removed

The clips are each secured with two spot welds and all came off cleanly using a small chisel before cleaning up with a Dremel and coating with Bonda-Primer to keep corrosion at bay. A frame was made with sections of 1" aluminium angle and riveted into place with a bed of intumescent sealer between the angle sections and the body.

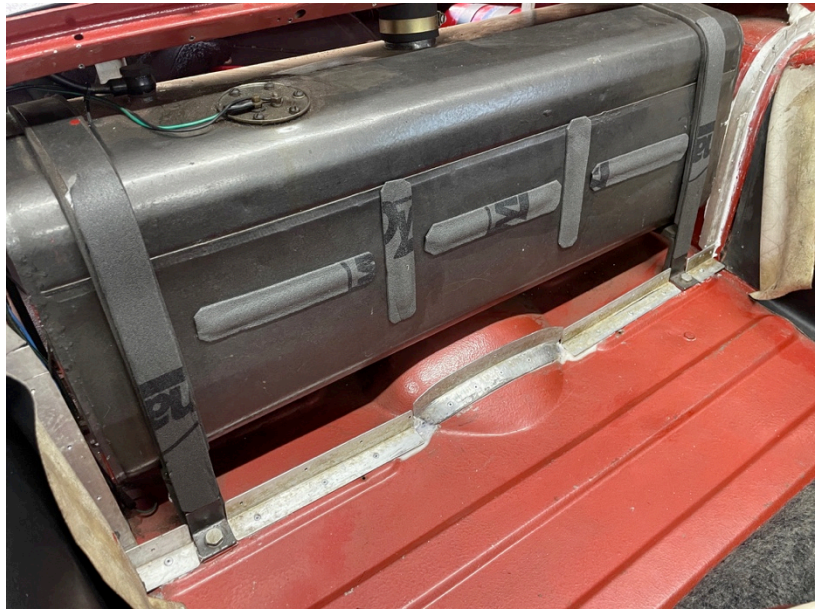
Angle frame in place with strips of Dynaliner on tank and straps

Strips of self-adhesive Dynaliner were stuck to the fuel tank and the mounting straps to negate any rattles.

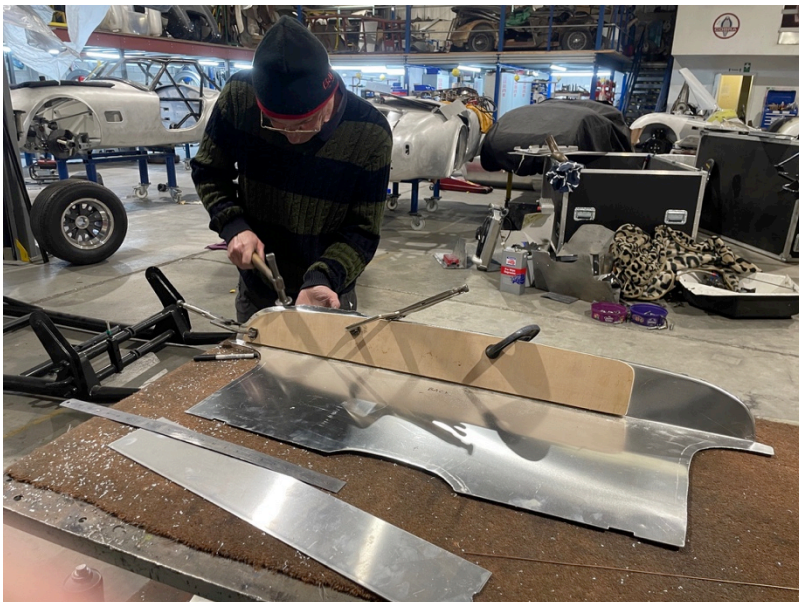
Paul using my bending buck to form the top flange and making it look easy.

With the mountings in place I reverted to CADD (cardboard Aided Design). I spent longer than I care to admit making a first draft template for the firewall from cardboard, and then refining it into a sturdier version made from hardboard ready to transfer to the final 1.2mm aluminium sheet. The firewall would need to have a 30mm flange bent along it's top edge to seal against the tonneau deck so a bending buck was made from 12mm ply to ensure an accurate fit. With the templates complete I dropped in to see our friends at North Devon Metalcraft to source a suitable sheet of aluminium. True to form Paul Evans became enthused with the project and I left their workshop with a fully formed firewall which required only minimal fettling before it was ready to be sealed and riveted into place.

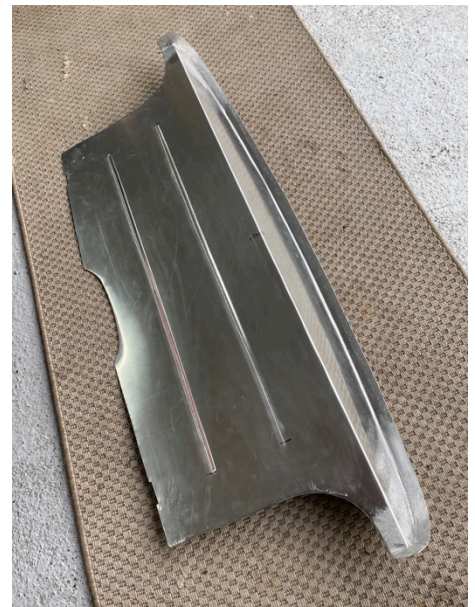
A couple of bead rolled flutes stiffened the flat panel.

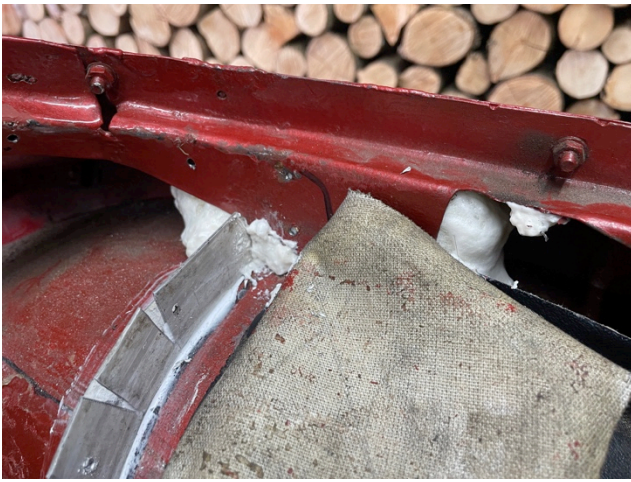
Foam seal over the wheel arch

The fully formed panel was fitted into place and drilled ready for riveting while being temporarily secured with Cleco skin pins. The voids at the tops of the wheel arches were sealed off with intumescent foam and the back of the firewall was treated to a layer of Dynamat to reduce any drumming.

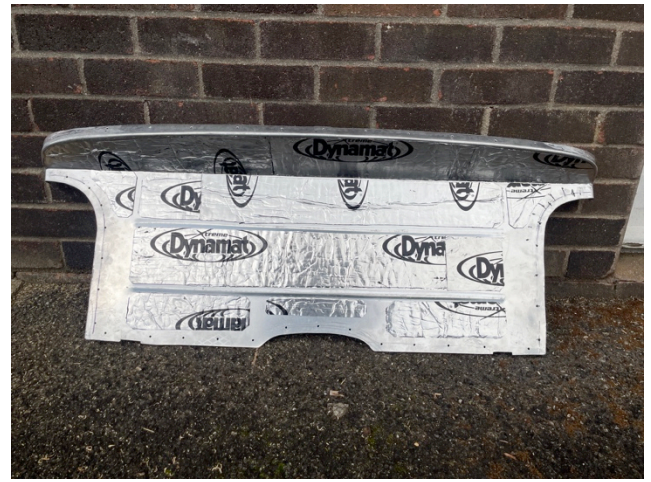
Firewall with Dynamat ready for fitting

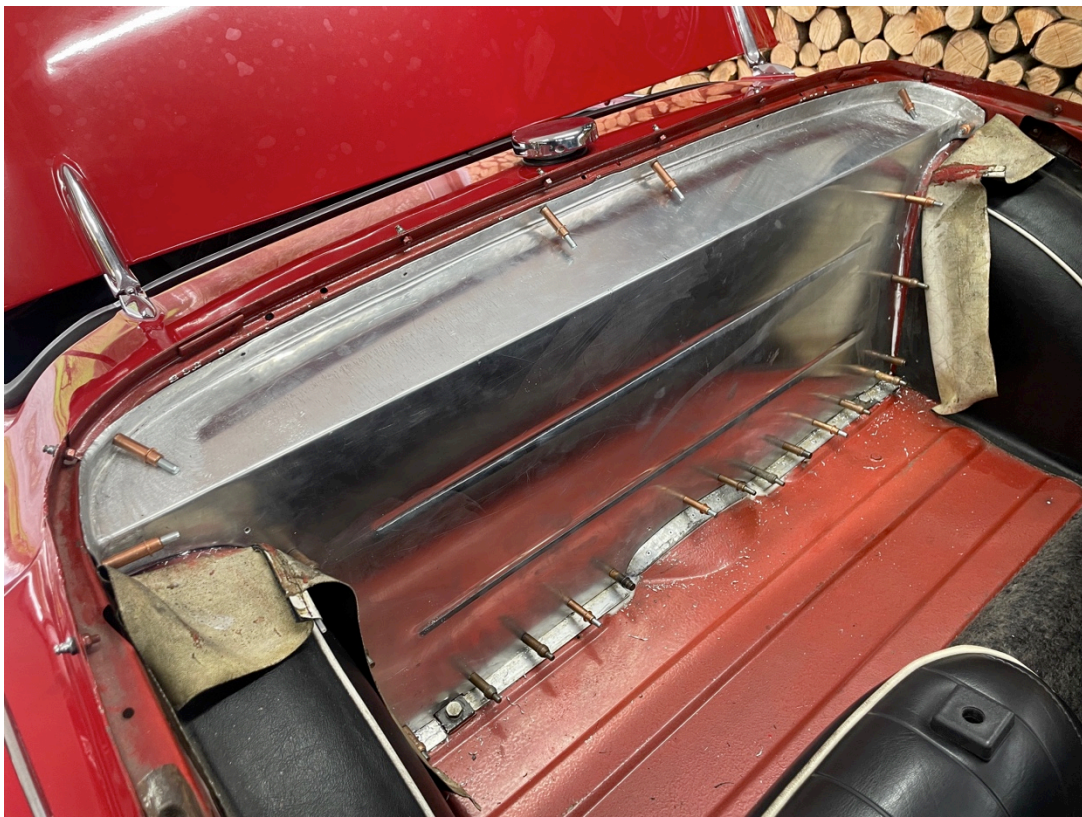
Firewall held in place with Cleco pins while being drilled for final riveting

The firewall was bedded onto a generous layer of intumescent sealant and riveted into place to form a fire and fuel proof barrier protecting the cockpit.

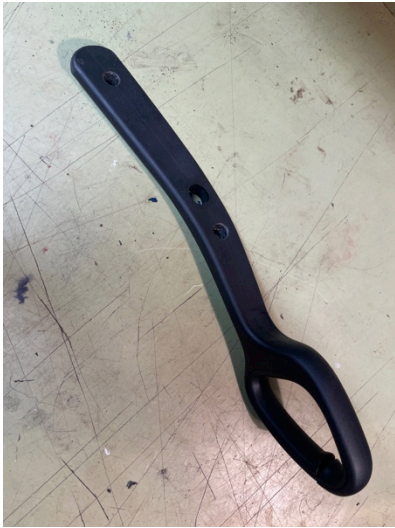
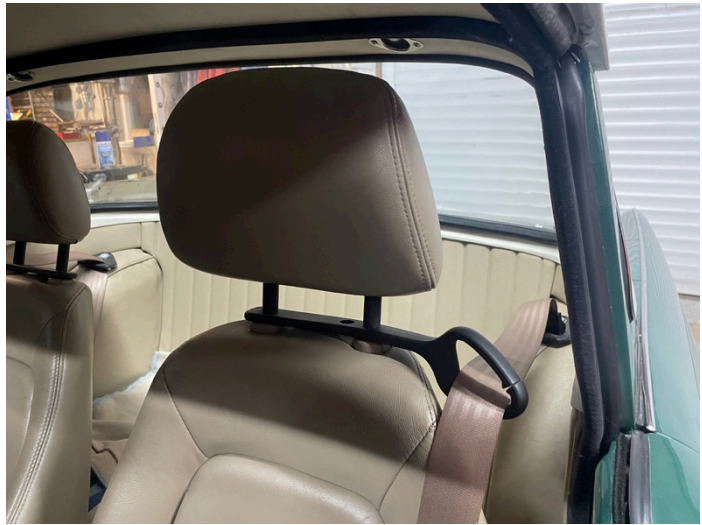
Additional holes were drilled to suit the MX5 headrest and the excess length trimmed off. Some rubber hose was slipped over the headrest prongs to keep the new guides snug down to the seat back.

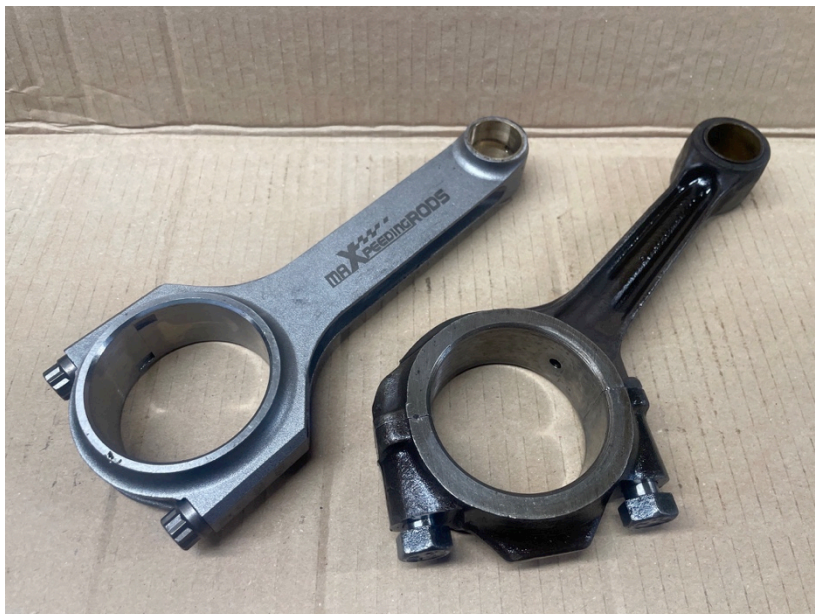
The new forged conrods are balanced to within 1g, weigh around 2/3 the weight of the standard item and are much stronger.

With the conrods on the bench all seemed well, the gudgeon pins being a good fit in the seemingly unworn small end bushes. Mystified at this point I cleaned the rods and pins in thinners to remove the oil film and blew them dry with an airline. With the components clean and dry slight play became obvious to the point where holding the pin at each end and jiggling it vertically produced an audible rattle. A quick visit to Bob Dove Racing for Bob's second opinion confirmed that the play was enough to cause the rattle that we could hear with the engine running.

I had a set of MaXpeeding forged conrods in stock that had been earmarked for use in the TR3, so the simple option was to press them into service for the rebuild.

It is notable that in this case the MaXpeeding conrods were a direct replacement for the standard parts and remained well clear of the bottom of the cylinder liners throughout the rotation of the crank. Some installers have found that the rods hit the liners so I suspect that some replacement liners may be longer than others.

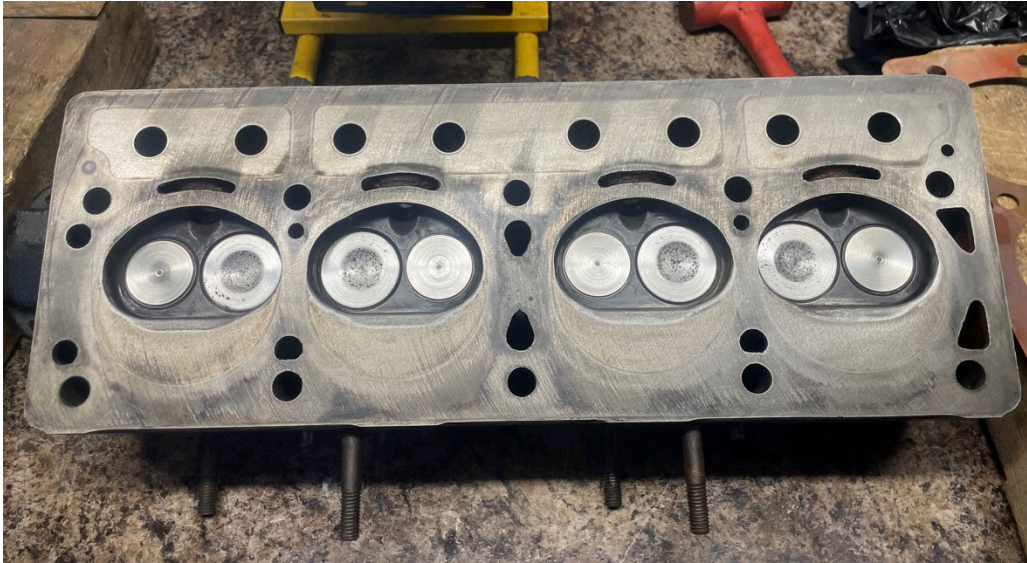
Cylinder head after "fettling"

I also took the opportunity to fettle the head a bit more. The valves were cleaned and the profiles modified to remove the distinct steps of the standard items and round the edges to improve the gas flow. The edges of the chambers were rounded off and smoothed adjacent to the valves and the valves given a light hand grind to improve the seats.

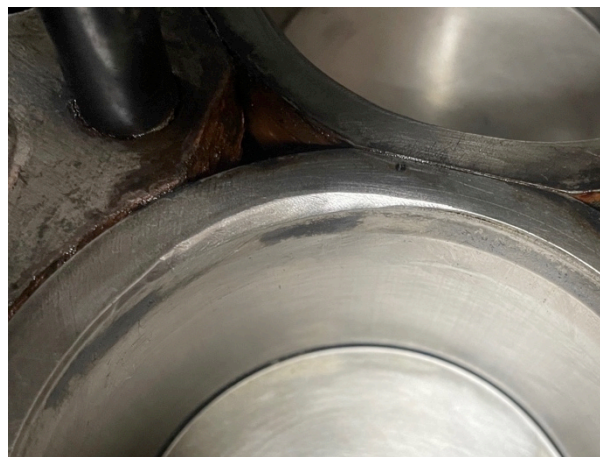
The small but useful chamfer on the edge of the liner

The edges of the cylinder liners were locally chamfered adjacent to the inlet valves to a point above the extent of travel of the top ring to improve the inlet gas flow, which is otherwise presented with a sharp step when the inlet valve shrouding is ground back.

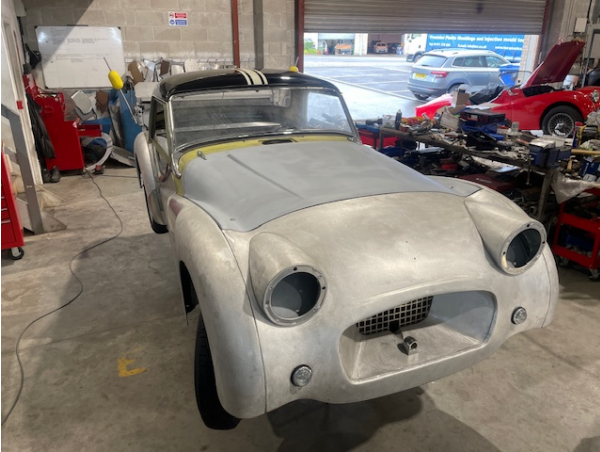
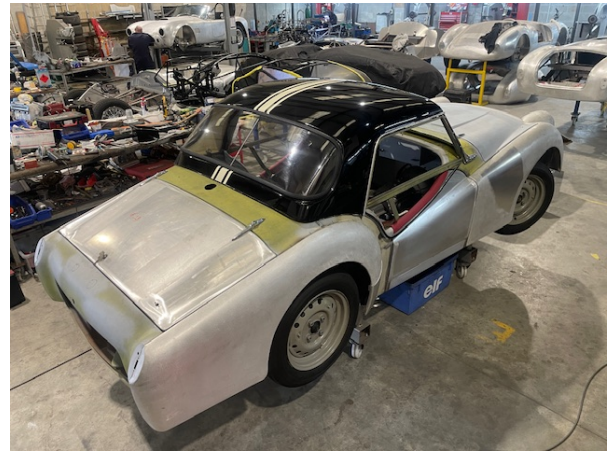
In the corner of North Devon Metalcraft's workshop Paul's long term TR2 rebuild is progressing slowly but surely. The aluminium body is now complete and ready for its coat of old English white paint. The hardtop is complete having already been painted and trimmed.

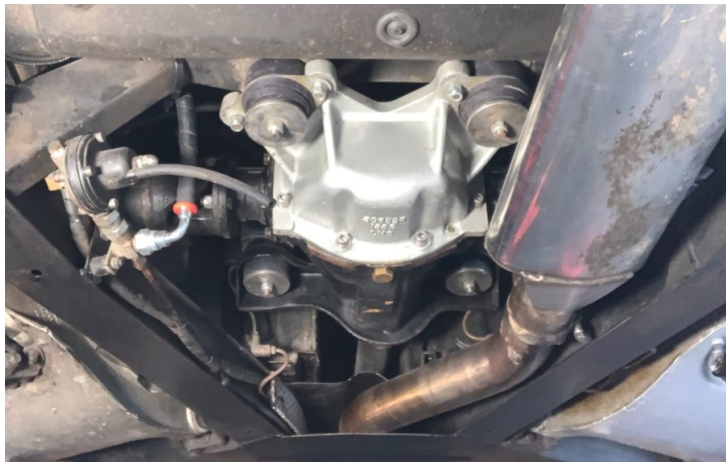
The new R9 hose with its elbow fitting connected to the pressure relief valve.

I then remembered SC parts, a supplier I had used in the past for a new door window glass. They listed the hose on their website and after contacting them to establish that the hose was at least R9, I ordered one. It was a bit pricy at £96.52 including post & packing and took seven days to arrive. To my surprise it was marked Made in the USA and I think it may have come direct from the manufacturer but it had the R9 rating marked on it so I was confident that it would be suitable for use with fuels that contain ethanol.

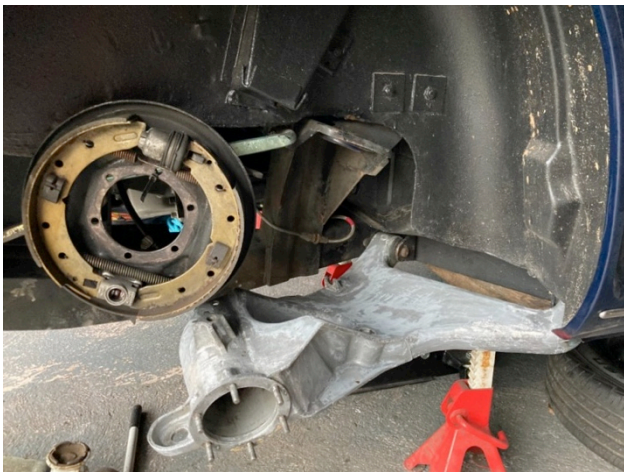
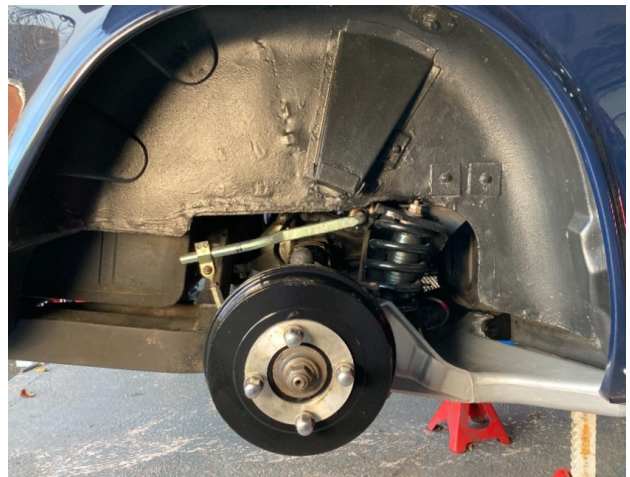
The next job was to remove the drive shafts to enable me to check and re-grease the outer universal joints. I use modified Datsun 180 drive shafts, which feature a CV joint and larger U/Js than the Triumph shafts. The outer grease nipple falls inside the swinging arm casting making it necessary to remove the shaft for routine re-greasing. With the half shaft removed I took the opportunity to clean the cast alloy swinging arms and check for any cracks or damage. All was well so I went on to clean the brakes with a spray cleaner from Parts Services and re-paint the brake drums.

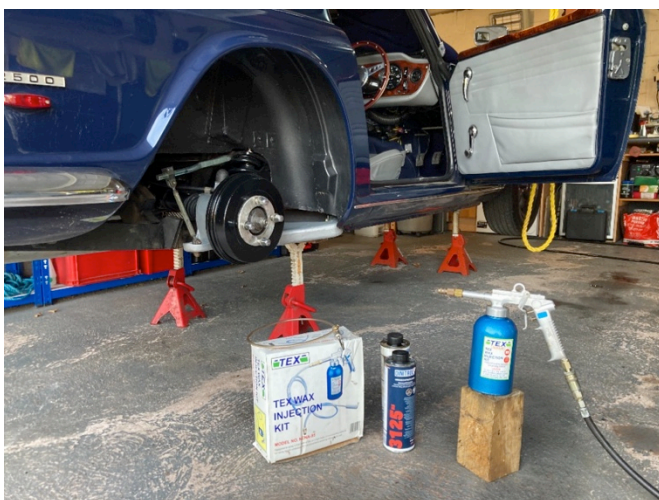
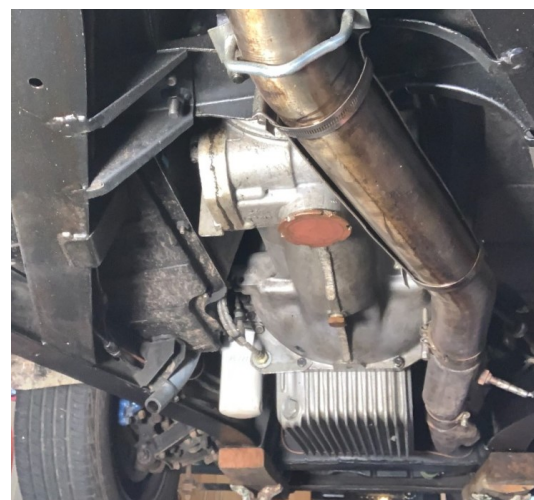
On to the next winter job, which is routinely repeated every three years or so. With TRs corrosion protection is key, so I treat the inner chassis with Dintrol cavity wax using a Texwax Injection Kit. A radial spray pipe passed up through the chassis rails from front to back including the inner chassis and cross members. I then change the spray nozzle to spray up into the bottom of the doors ensuring that the windows are raised to avoid waxing the glass. The upper seat belt mountings are then removed to spraying down inside the B post.

The carpeted kick panels are then removed from the foot well sides to gain access to the inside of the A post. The final job is to spray the plenum chamber through the air vent flap on the scuttle that supplies air to the heater. Not too much here as it can get into the heater blower.

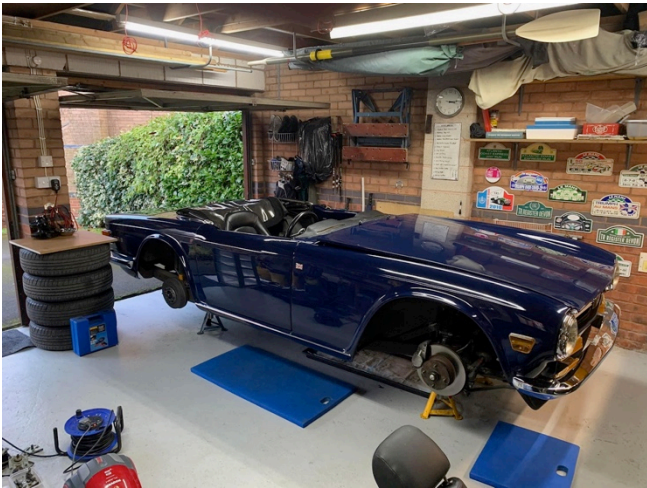
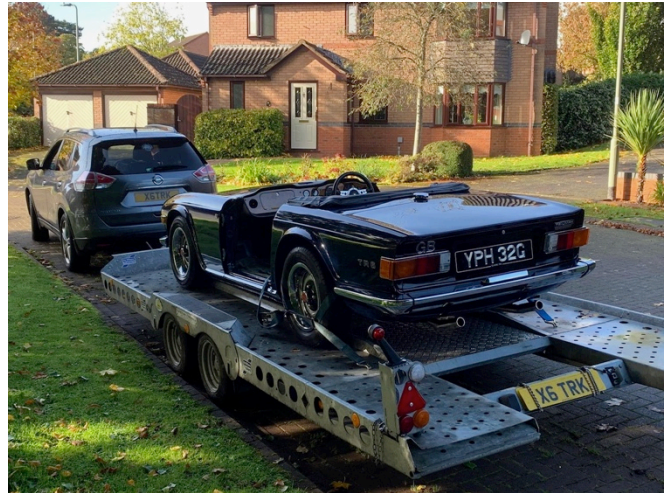
Martin Lovell's TR6 is being treated to some minor rust repairs and paintwork improvements.

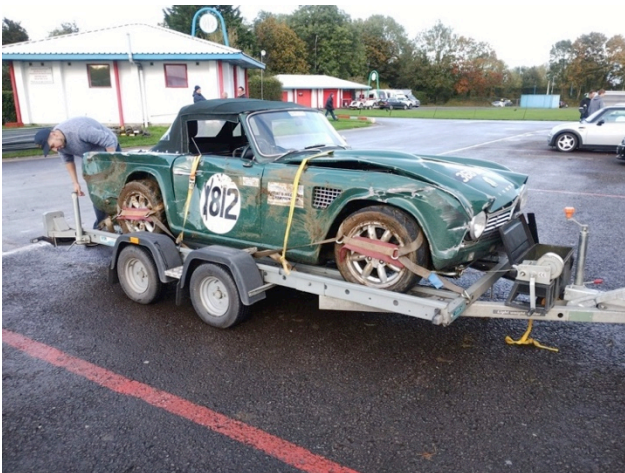
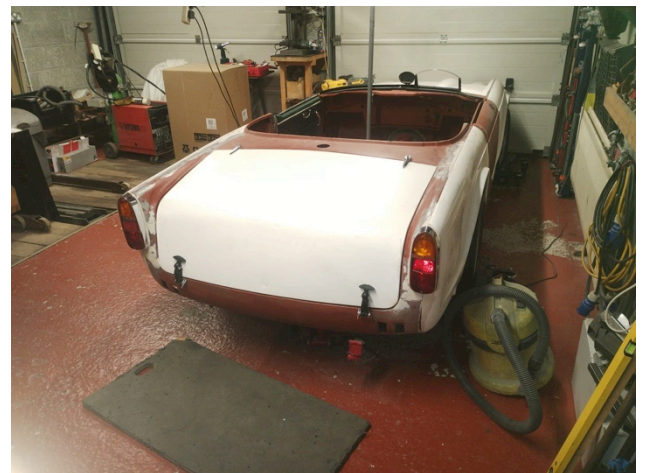
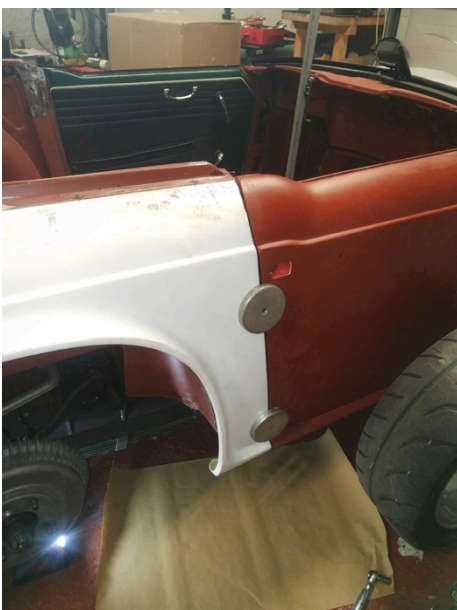
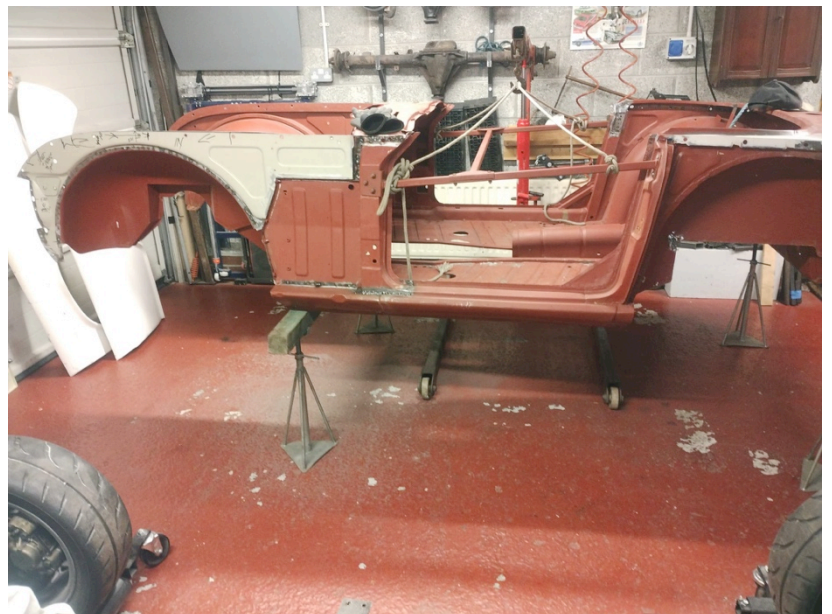
After his 'off' last year John Blake has been working hard to rebuild his TR4 body ready for the 2024 Hillclimb Series.
