TR7 Rebuild

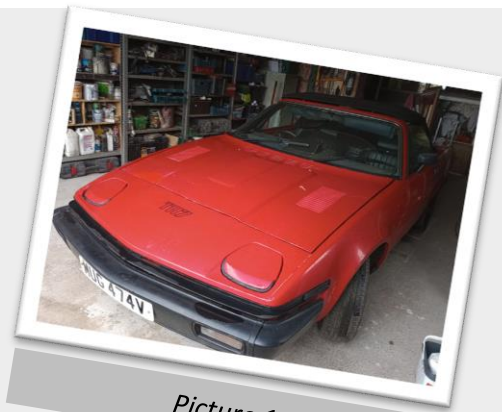
Picture 1

converted to V8 which I found on Ebay at a very reasonable price. I went to look at it and it seemed to fit the criteria and inevitably I bought it on the spot (pic1: TR7 as bought). After I took delivery, the intention was to drive it for a few weeks in order to find out what needed doing to it. A closer inspection led me to philosophically accept Meat Loaf's advice and realise that "two out of three ain't bad". It was going to require more than a few quick fixes including a complete rewire, removal of several areas of 'structural' filler, lots of reversal of the PO's attempts at fixing it and more welding than I wanted to do whilst lying underneath it.

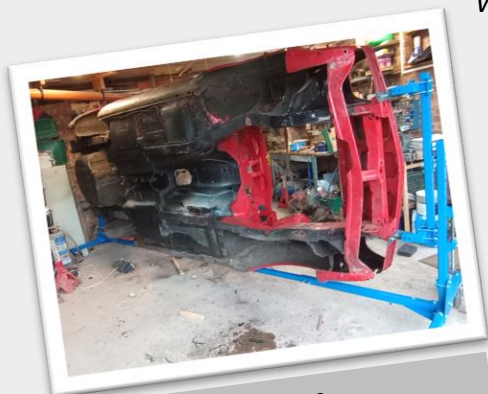
Picture 2

The first step was to strip it down to a bare shell, bagging and labelling everything and trying to remember to take photographs of areas which might be useful later. This done I acquired a rotisserie which is

something that I cannot recommend highly enough. (pic2: TR7 rotisserie) There were several weeks of welding and associated bodywork to do, and this piece of kit makes it easy. There are not many pictures of what I needed to weld but a good example of the approach taken is with the nearside door where the frame had rotted out at the bottom all the way from the front to the back. I could have bought another door or reframed and skinned the one I had but that is not my style, so I cut out all the rotten frame and peeled back the lower edge of the door skin to allow the introduction of a couple of pieces of steel to replace the rotten portion of the frame. I then used PU sealer to stick the new steel to the outer door skin and tapped the door skin edge back down, holding the

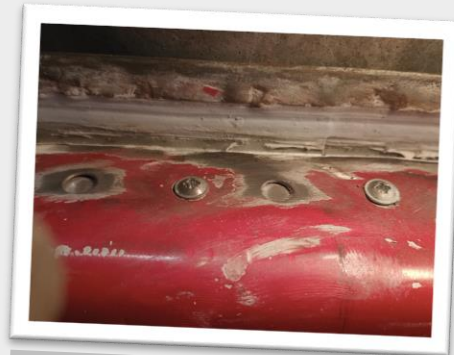
Picture 3

pieces in place with self-tappers ready to be plug welded to the frame when the sealer is set. (pic3: Photo door 1) The screws are removed and more plug welding finishes the structure. (pic4: photo door 2) A little grinding flat, some filler and elbow grease and the door is serviceable again with minimal cash outlay. (pic5: photo door 3) This is basically the process used all over the body where possible, the only new panel being bought was a cover sill.

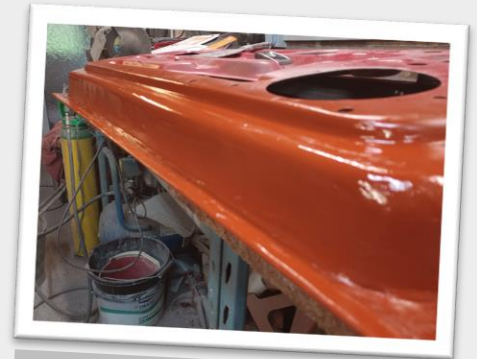
Picture 5

I am now well into stage 3, There's a bit more filler to put on to smooth things out, then I'm going to spray it using cellulose for easy future repairs.
