In The Garage

Feb 2023

Issue 17

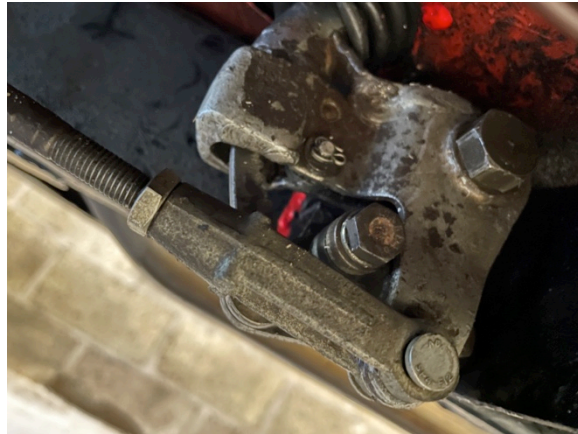
I tried fitting a long bolt to the rear bracket attachment with a spacer over the shank to act as a stop. It brought the "off" position closer to the driver but restricted the overall movement to a level where the cable adjustment needed to be too tight and it proved difficult to get the rear drum brakes sufficiently free when "off".

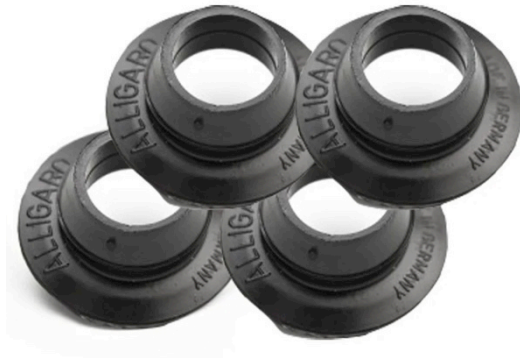
TR15 to TR13 Ferrules

First of all there are two valve hole sizes, a larger TR15 hole and the smaller TR13 as used on more modern wheels. The wheel in question had the larger hole and the old inner tube had the corresponding TR15 valve. As the replacement tube had the smaller TR13 valve a plastic TR13 to TR15 ferule was required.

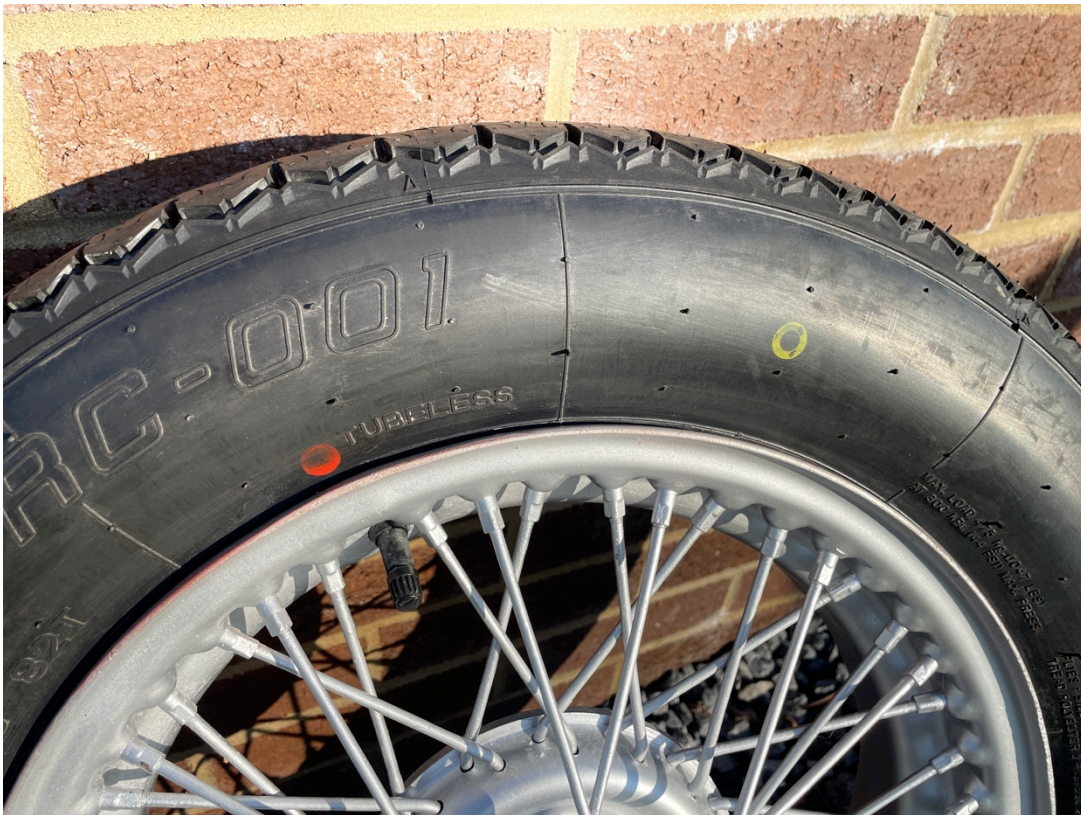
The yellow dots identify where a tyre weighs the least — the lightest point on a tyre. The yellow dot should be lined up next to the valve stem, which should be the wheel's heaviest point.

The red dots identify where the tyre is highest, usually where the belts are joined in the carcass. The red dot should be aligned with the low point of the wheel, which is usually indicated by a coloured dot or a notch on the wheel.

If a tyre has a yellow and red dot, the red dot takes precedence when fitting as the 'light spot' can be balanced out with rim weights. As it happens, the low spot on my spare wheel was adjacent to the valve hole!

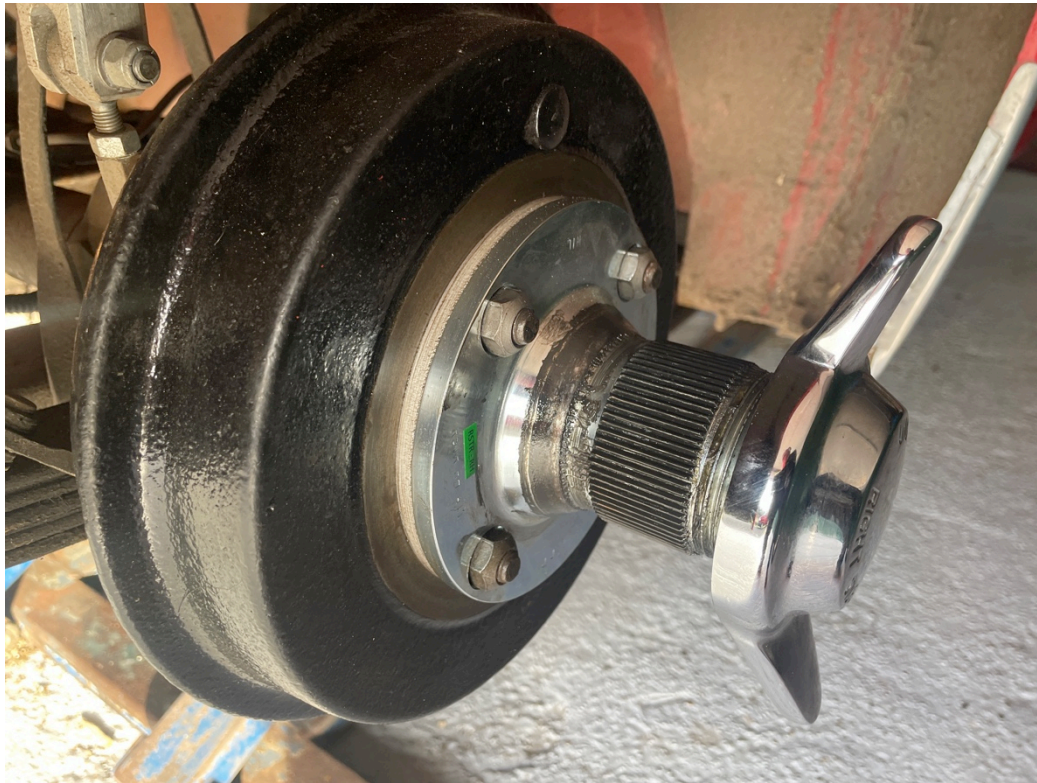
As can be seen pictured above the low profile double chamfered nuts leave precious little flat for a socket to locate on when tightening to the correct 65 lb/ft. This can be problematic, especially when the new adaptors from MWS are used as they have a slightly deeper counter-bore than the original Stanpart items. Problems can be minimised by using a six-point socket rather than the more common 12 point bi-hex type and chamfering the edge to fit as far into the counter-bore as possible. I use high strength Loctite on these to ensure that they don't come loose over time.

There are a few other idiosyncrasies attached to wire wheels on Triumphs, not least the fact that the wire wheel adaptors require shorter studs and low profile double chamfered nuts to clear the back of the wire wheel hub. I get around this by fitting a ¼" spacer between the adaptor and hub. This simple measure ensures that should I wish to revert to bolt on wheels they can still be fitted. A useful facility when travelling in a group as should I be unlucky enough to suffer a double puncture a borrowed bolt on spare can still be used.

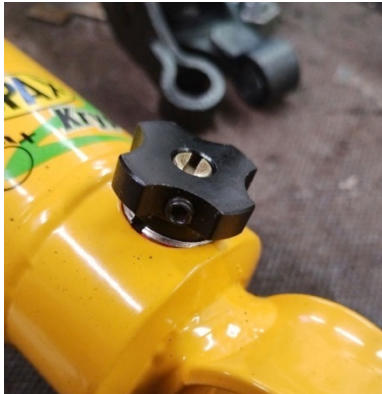
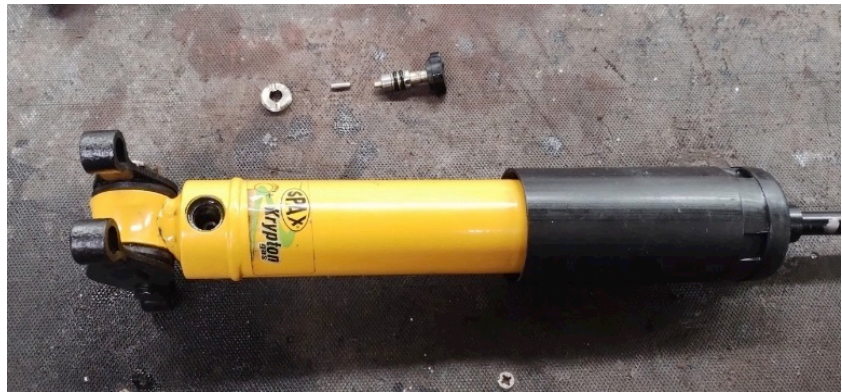
When turning the adjuster anti-clockwise back to zero I hadn't realised that I was also turning the housing fitted to the body of the unit, and the whole assembly shot out at considerable speed driven by the pressurised gas and oil within.

I suspect that the adjuster wheel contacting the spring pan had not only damaged the wheel, but the intermittent impact had compromised the security of the adjuster assembly in the body of the shock absorber. The bosses have very little thread and it is quite possible that if undiscovered, they could have blown out in service.

At the time I didn't consider it much of a problem but resolved to adjust the shock to zero and reset it to match my new springs before removing the adjuster knob. It is only secured by a single 2mm grub-screw. Any subsequent adjustments could be made with a screwdriver in the slotted adjuster screw.

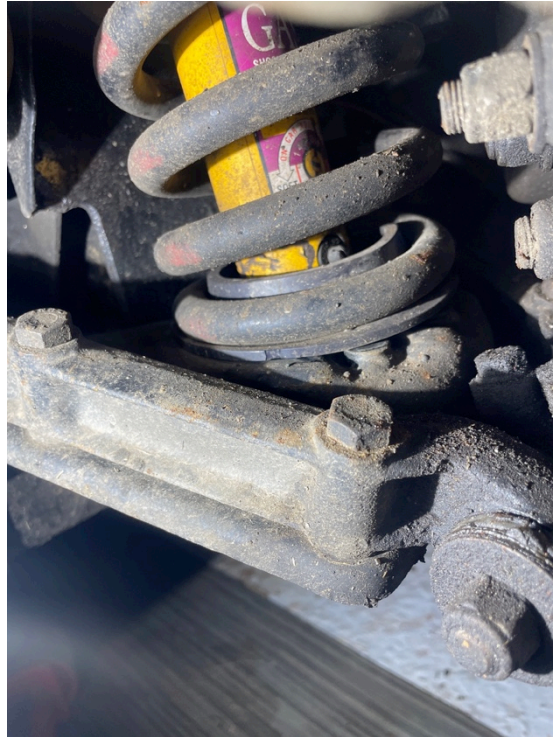
Ed: Subsequent to John's experience I've checked my Spax equipped TR4 and was pleased to confirm that it is fitted with the earlier design adjuster as pictured below. These shock absorbers were fitted around 20 years ago prior to the manufacturer's design revisions.
