Chris's TR 4 rebuild

✉ Chris Mountford

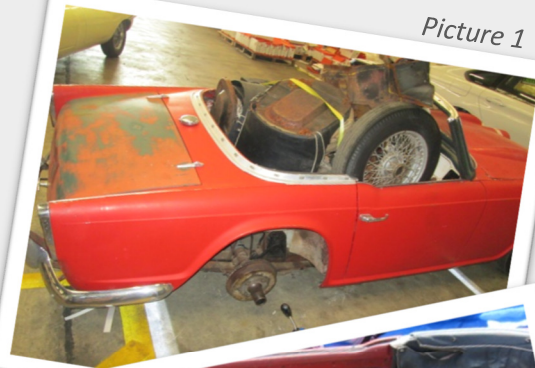
Picture 1

The Story so far, TR4 imported from USA (a couple of years ago) in shipping container, arrived in Felixstowe but the 'nut' for the rear offside wire wheel was missing (Picture 1). With no nut to hold the wheel on they had no option but to drag it out after trying to lift it with a forklift. Needless to say the back of the car was mangled. The mystery of who stole the nut when it was on the docks in New York will probably never be solved.

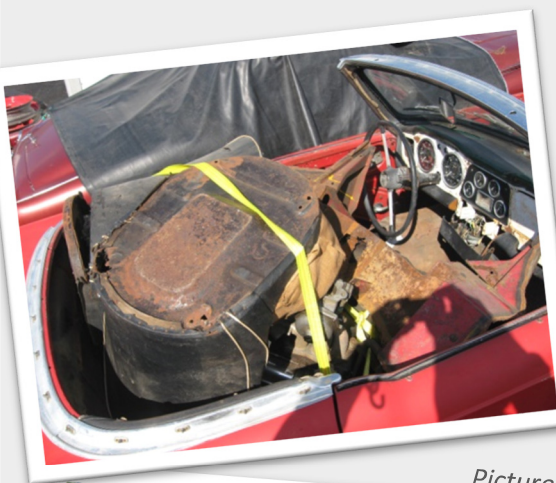
Picture 3

years! It has given me the time to process the TR4 rebuild. It's not all bad as long as I don't catch CV19..... Although with this thing I am likely to get a severe dose of ferrous Oxide ☺. First job was to strip the body off the chassis and put on a dolly 'upside down' (Picture 2) so that I could access the areas to be repaired / replaced. I've attached a random selection from early on (picture 3&4)

Having stripped it down, I am replacing the floors, Sills, Inner sills all the bulkhead edges, and converting it to RHD, oh, and putting a front bulkhead back in where it had been 'torched' out with Oxy

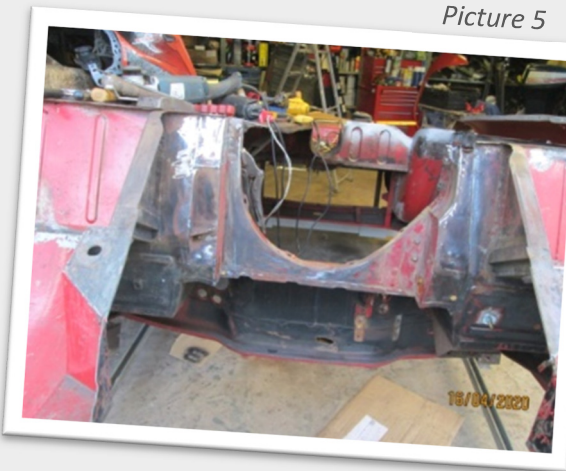
Picture 5

Acet bottles to fit a V8 over in the States. (Picture 5).
